MACH 2

Concorde
magazine

Issue 6
October 2016

OUTSTANDING FEATURES

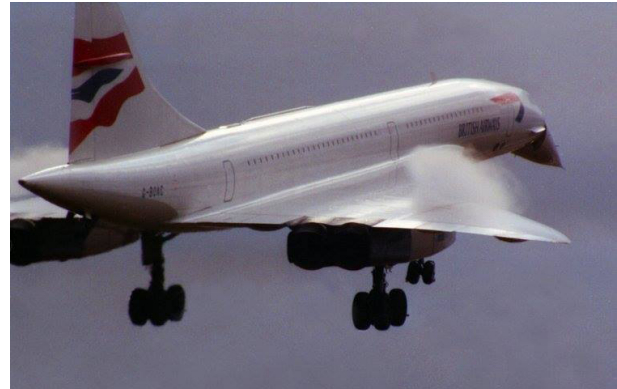
Soft landing

Concorde G-BOAC in typical landing attitude as she comes in to runway 27L at Heathrow.

4 Concorde was a naturally soft-landing aircraft. Due to the delta wing design, as she approached the runway, she would create a huge cushion of air under the wings: the ‘ground cushion effect’. At 15 feet, when the throttles were retarded to idle, the pilot would select a small amount of back stick, to counteract the ground cushion tending to pitch the nose down. Landing Concorde was a balancing act, and it was essential this was achieved correctly, to ensure a ‘positive’ touchdown of the main wheels – i.e., not bouncing, so then the nose wheel could be landed and the main wheel brakes activated; prior

to this they were inhibited until the nose wheel was travelling at the same speed as the main wheels. (Then when reverse thrust was selected, full forward stick would be selected to counteract the pitch-up attitude that reverse would initiate.)

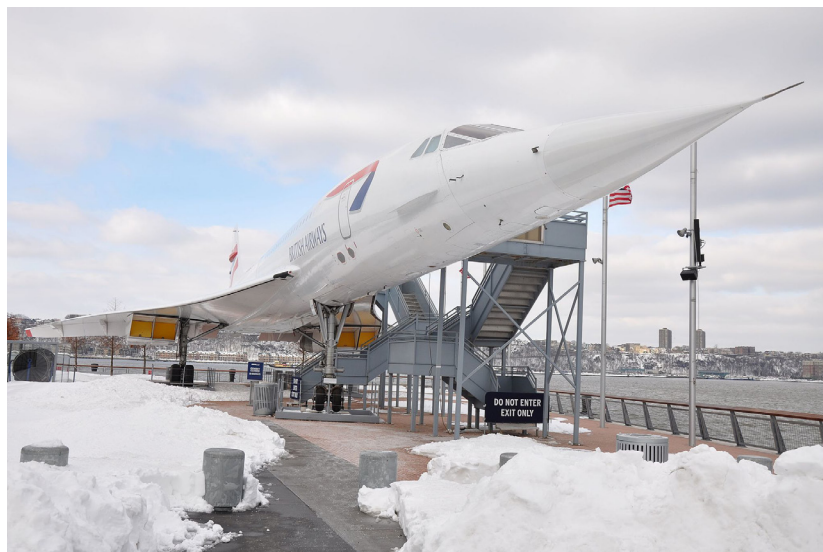
Tough conditions

Concorde G-BOAD on display in winter at the USS Intrepid museum, New York. While in service, Concorde coped with any extremes of weather, including heavy snow.

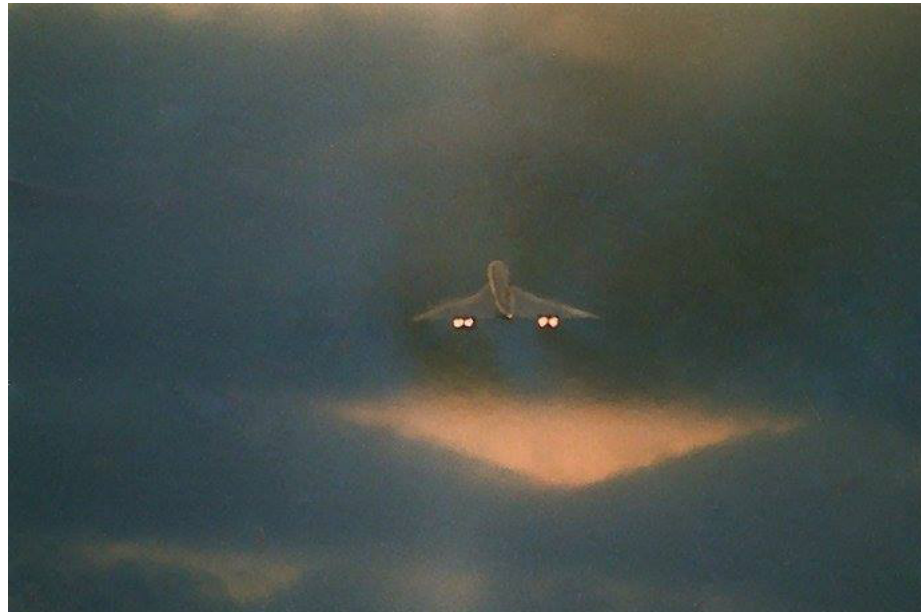
Braving the storms

Concorde takes off into a stormy sky at Heathrow. Even in automatic pilot, Concorde showed she could overcome any challenge.

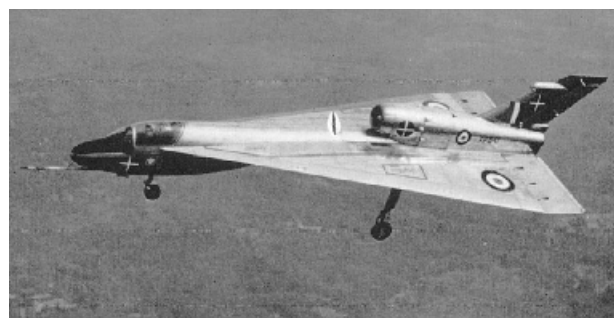
Test aircraft

The Handley Page HP.115 was used in developing Concorde, to test the action of a slender delta at low speeds. *Photo: Unknown source (no copyright)*

There is an ideal angle for the wing leading edges for high-speed flight – around 22° from the aircraft's centre line. The front portion of Concorde's wings were at roughly this angle – but if the entire wing had been like this, then Concorde would have been very much longer. Instead, the wings flared into a 'double delta' shape, with the leading edge forming an 'ogee' curve.

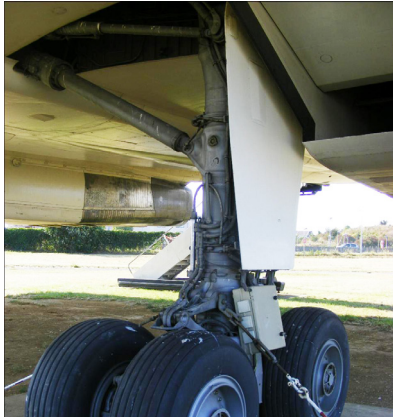
Telescopic structure

The undercarriage at its full extent. On take-off, the legs would shorten before retracting into the landing gear bays. *Photo: Mathieu Marquer / Wikimedia Commons*

The main undercarriage on Concorde was especially tall, to minimise the risk of the exhaust secondary nozzles and the extreme end of the tail coming into contact with the runway on take-off.

The engine nacelles were positioned as far out as possible before the droop of the outer wings limited their position. This in turn dictated the undercarriage position. But on retraction, the undercarriage would have been too long to fit into the landing gear bays. A clever solution was employed by the use of a shortening jack in the mechanism, which reduced the length of the undercarriage by about 6 inches so that the wheels would fit into the bays.

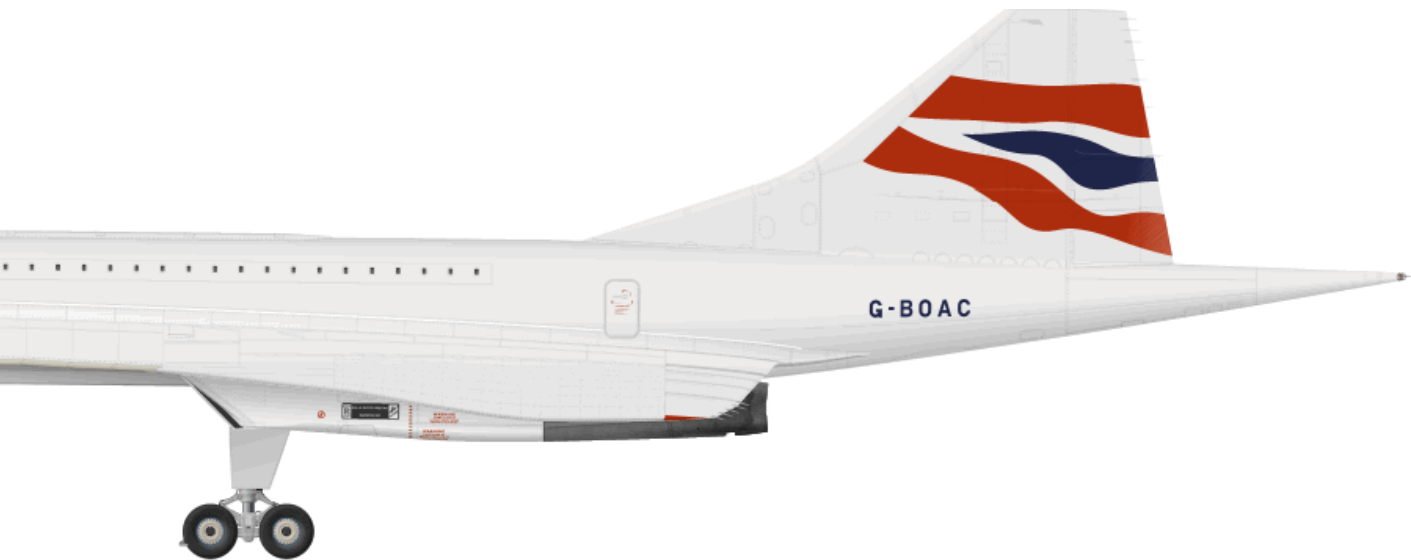
5 Engine nacelles

At the top edge of the engine nacelles, above the front lip of the intakes, is a small gap. This extends back over the length of the intake section, tapering out as a 'V' shaped wedge. This is designed to maintain boundary layer airflow on the wing undersurface, because the nacelles take up a fair amount of space.

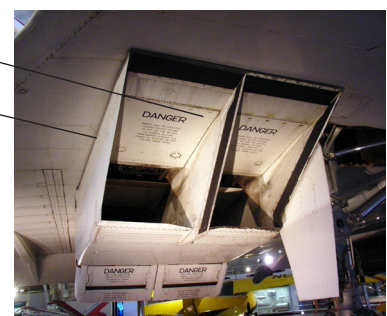
Engine nacelles

Air intakes

Gap
