MACH 2

Concorde
magazine

Issue 12
October 2017

Concorde flight testing

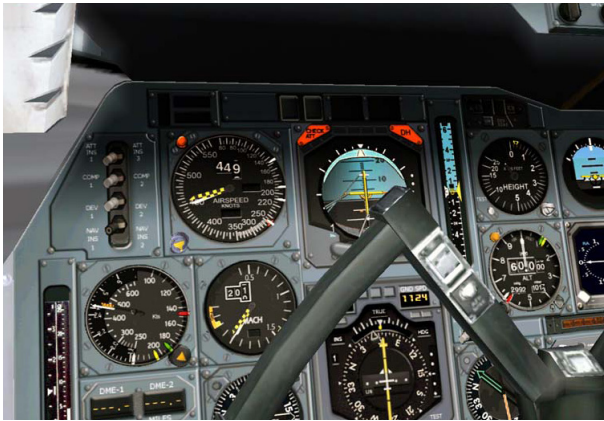
Captain's instruments

The airspeed indicator is seen in the top row of the panel, second from left, with the striped needle clearly visible.
Photo: David Macdonald

Looking at the flight envelope, Vmo begins at 300 knots at sea level, increasing to 400 knots by 5,000 feet, then holding at 400 knots until 33,000 feet, then out to 530 knots between 44,000 feet and 50,000 feet where it becomes Mach 2. This profile is calculated by the Air Data Computers and presented as a striped needle on the airspeed indicators.

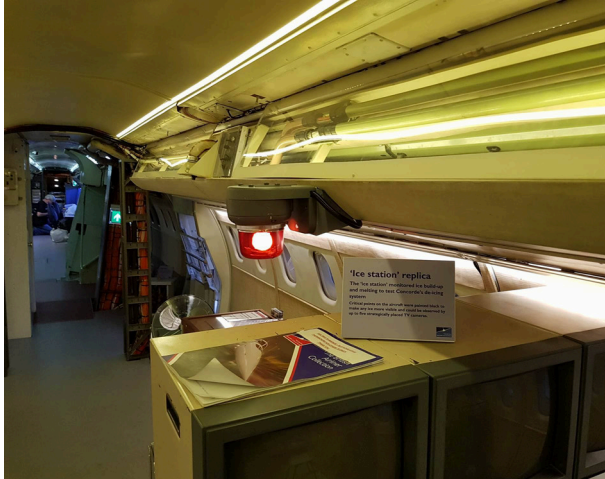
Restored to action

Left: the original red “evacuate aircraft” light. Right: the monitors that were originally used to view ice build-up during flight, now set up to show a film about this work.
Photos: Graham Cahill

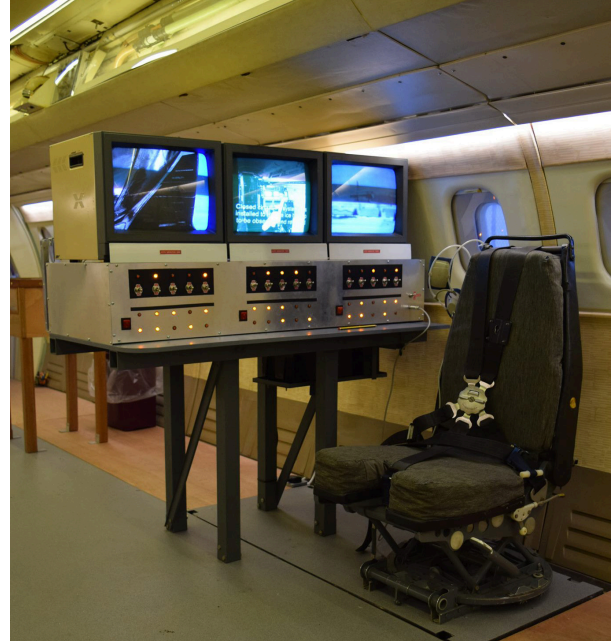
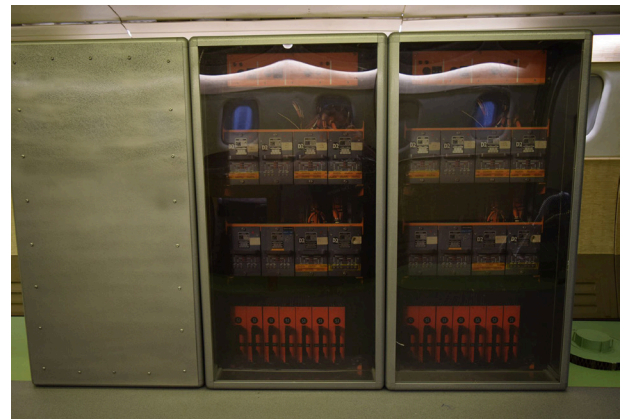
Zonal units

Above: replicas of the zonal units (test data units) have been constructed by the Duxford Aviation Society.
Photo: Graham Cahill

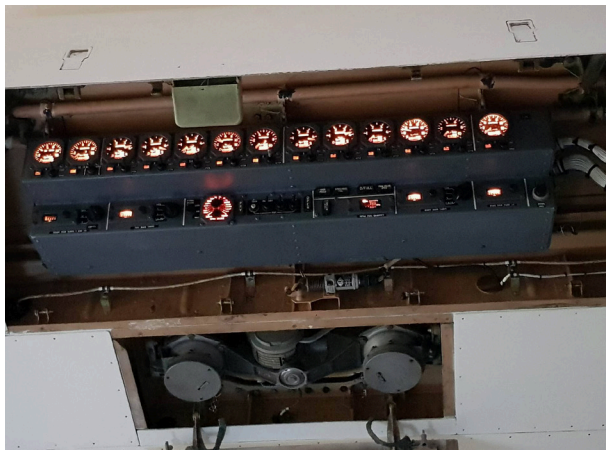
Fuel panel

The dials for the fuel panel, in the underside of the aircraft. Duxford had never opened the panel until Heritage Concorde requested this, and the group has now restored and relit the dials.
