MACH 2

FOCUS ON ENGINEERING
*Concorde operations through
the decades*

Issue 26
May 2020

A TECHNICAL TRIUMPH

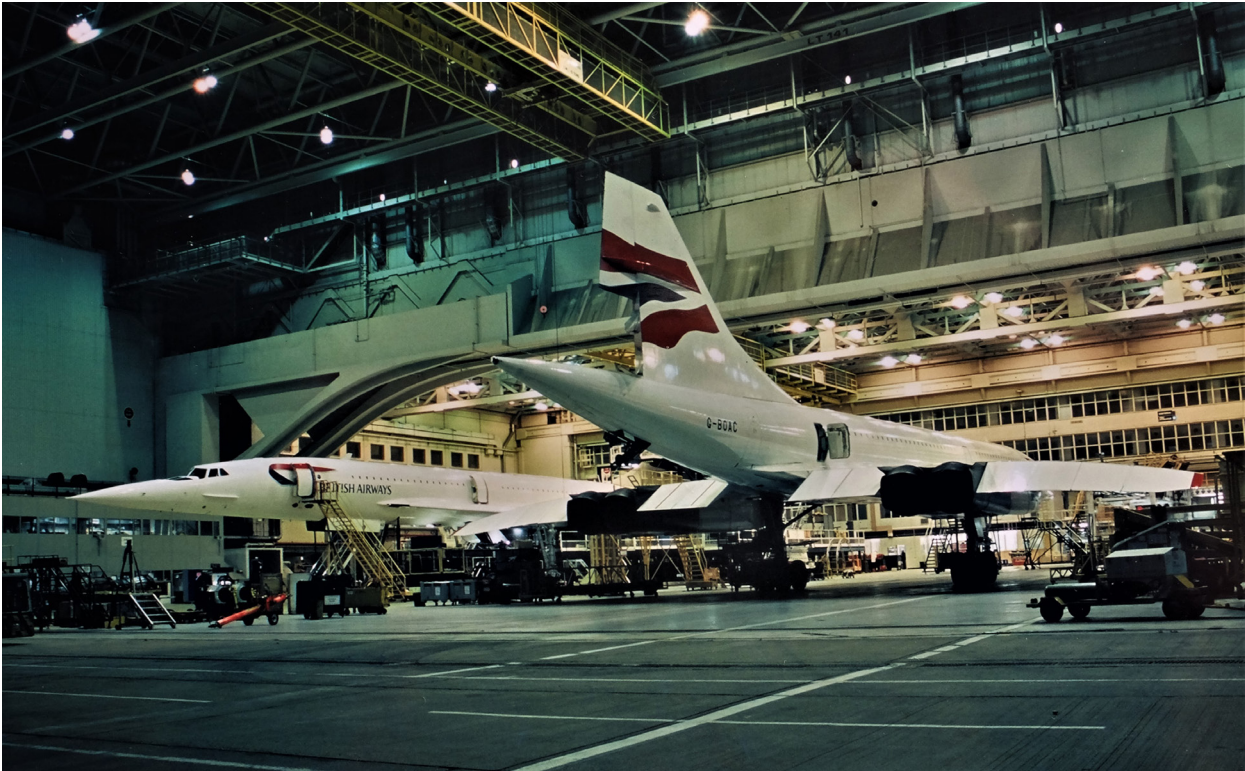
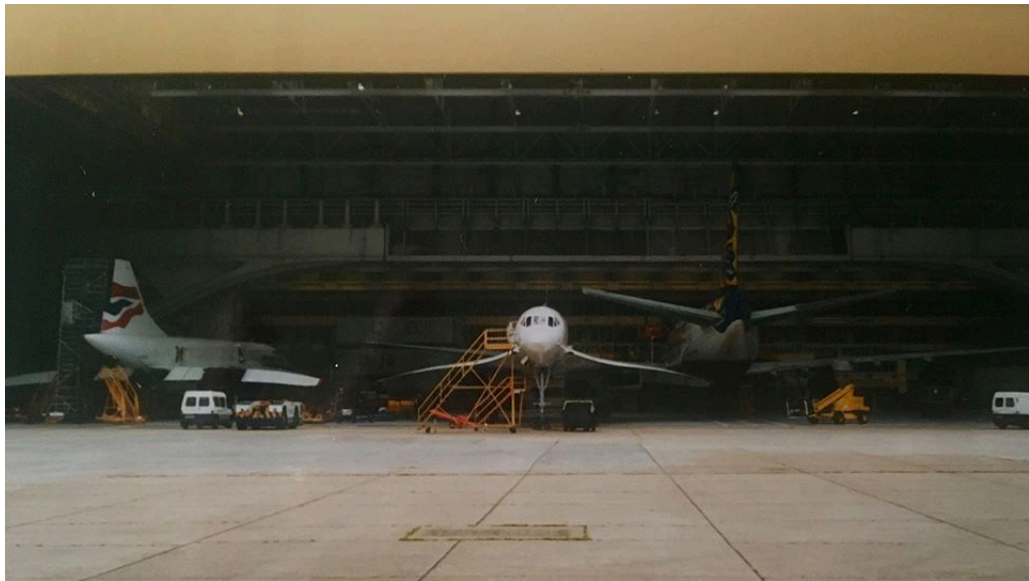
24-hour operation
Above and left: The Concorde engineering teams worked around the clock to ensure that the next day's flights would leave on time.
Photos: Peter Ugle

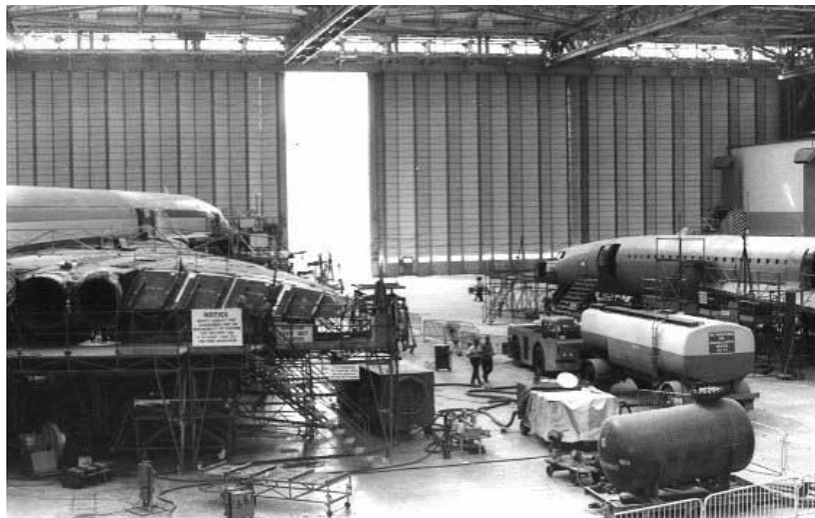
Brabazon hangar, Filton

Concordes under construction, 1971: G-AXDN (left) is structurally complete; G-BBDG (right) is being assembled. Photo: Christian Julius (with thanks to the Julius family for permission to use)

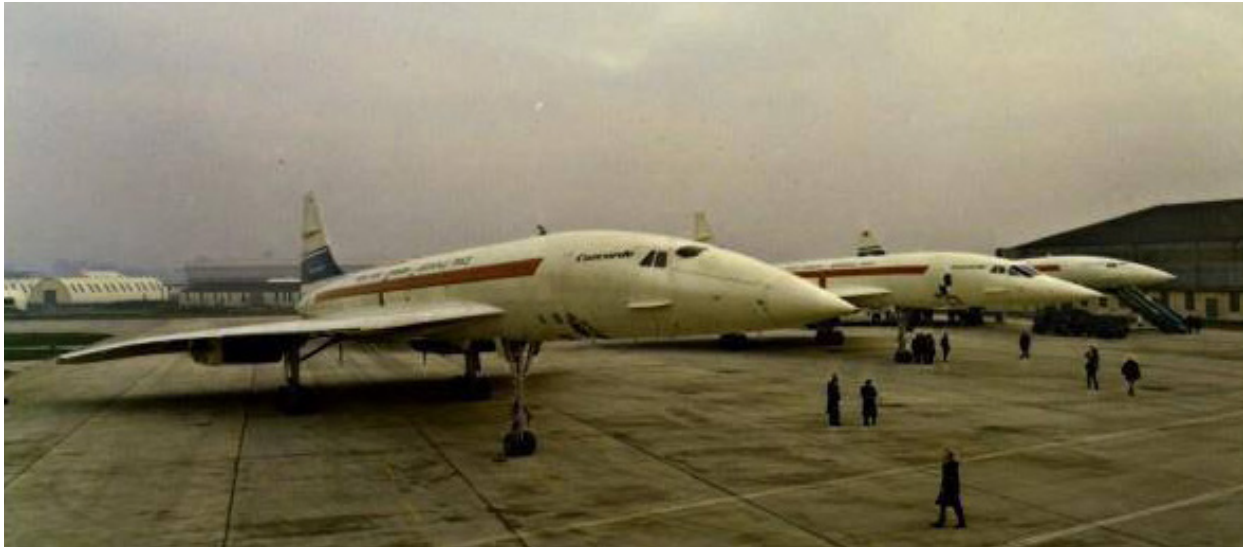
Rare sighting at Fairford

7 January 1972: French prototype 001 (right) with British prototype 002 (left) and pre-production Concorde 101 (centre), at a publicity event. *Photo: John Dunlevy*

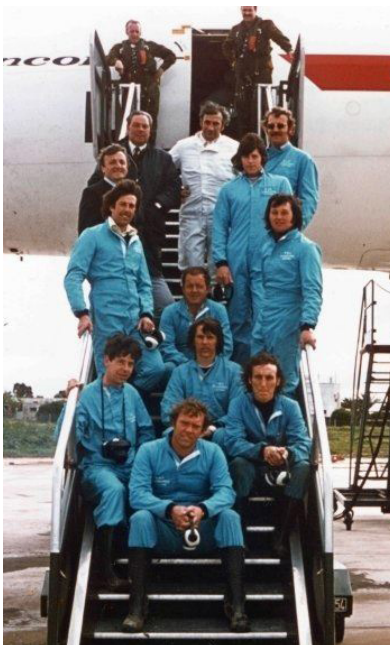
Flight testing in Tangier

Left: BAC engineers with G-AXDN during flight testing in Tangier, Morocco; John Dunlevy is centre right, holding the ear defenders. *Photo: John Dunlevy*

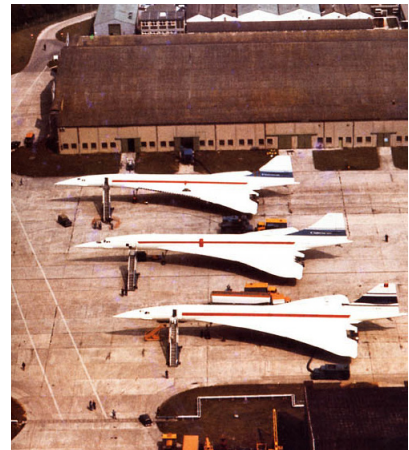
Aerial view

The two prototypes with G-AXDN. *Photo © BAE SYSTEMS*

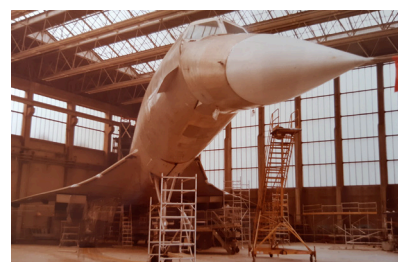
Work on Alpha Golf

G-BOAG needed extensive work in the early years. Here, she awaits repainting in 1984, after being grounded due to hydraulic system contamination.

At that point AG was taken into work; she was parked outside TBB West (TBBW) for a while, until licensed Concorde engineers Keith Leyland and Eric Smith took her on as a separate project to bring her up to BA fleet standard. This was a massive undertaking; it was always virtually impossible to maintain a full set of components, due to constant shortages, hydraulic fluid contamination checks, and rectification needed to restore any breakdown of chemical structure due to inactivity of the system.

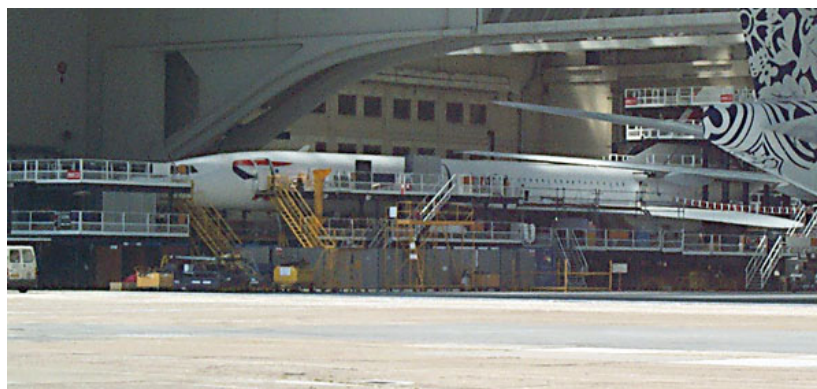
Flight delay

G-BOAC returns to the stand due to an intake problem. Engineering carried out preventative maintenance to keep such incidents to a minimum.

Rear intake ramp vibration at Mach 1.8, generated by a sharp lip: to rectify this a modified rounded lip was developed over time, and temporary revised flight crew procedures were introduced pending modification;

the vibration would, however, affect the rear ramp hinge line, with a large unplanned maintenance downtime needed to re-engineer this structure.

Some of the fleet required all of the intake assemblies to be removed, to allow access to rework and rewire all circuits associated with ramp and spill door control; these were complex tasks involving months of downtime for the aircraft.

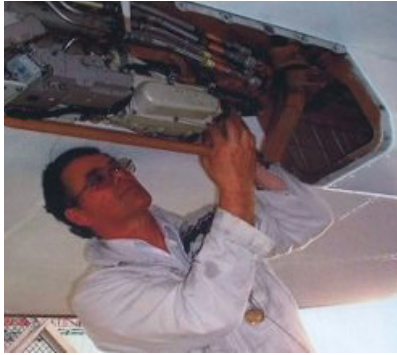
Close work

Left: Engineer Baz Glenister reconnects hydraulic hoses on an outer elevon PFCU.

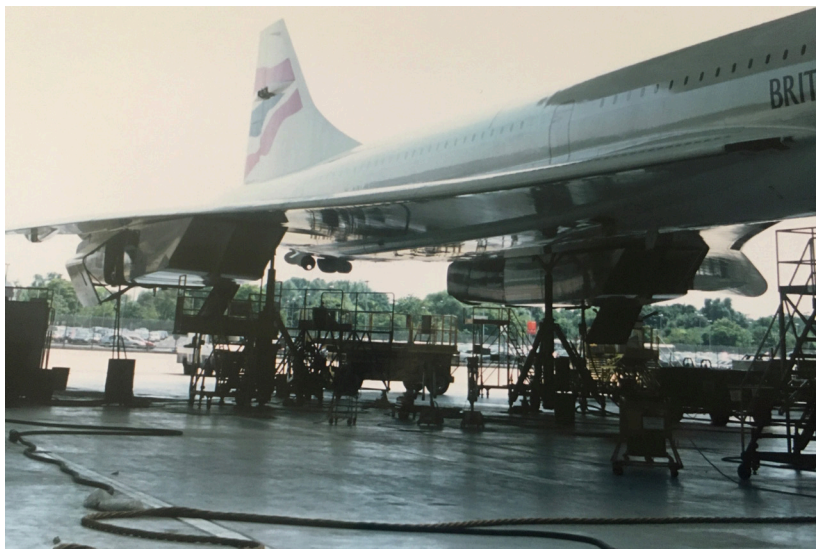
'Flying' over the floor

Below: G-BOAE raised on jacks, with the landing gear up and the engine bays open, as the engineers correct a problem with the hydraulics.

Concorde's hydraulic system has a 4000 psi operating pressure. As aircraft flying time increased, the hydraulic system seals' durability suffered. This issue was brought about by the massive changes in

operating temperature, thus subjecting the system to sub-optimal operating standards. In response, the manufacturers developed a new seal (known as Viton GLT) specially designed for both Mach 2 high-temperature operations and subsonic low-temperature cold soak conditions. Replacement took time, with a preventative maintenance programme that entailed multiple hydraulic component changes, including powered flying control unit (PFCU) relay and feel unit replacements, all requiring leak, rigging and function testing. This was a massive undertaking, challenging all engineers tasked with supplying airworthy Concorde.

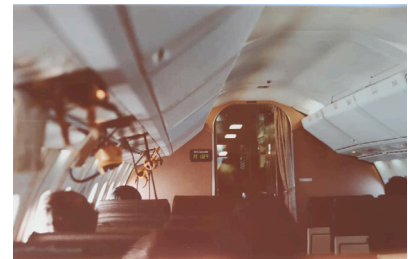
Test flight

Post-modification Certification of Airworthiness test flight on G-BOAF, March 1982. *Photo: David Gee*

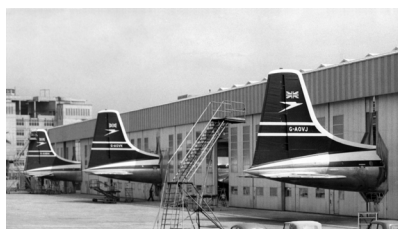
The Wing Hangar

Bristol Britannias in the Wing Hangar, 1958. The building accommodated just the wings, engines, and fuselages. Photo: *Mirrorpix / Alamy*

Concorde Maintenance found a home in a building named ‘Technical Block B’ (TBB) at the east end of Heathrow. But that hangar wasn’t always so named; it was originally ‘The Wing Hangar’, designed to house the Bristol Britannia 102 and its Bristol Proteus turbo-props. Just
