MACH 2

Concorde
magazine

Issue 30
May 2021

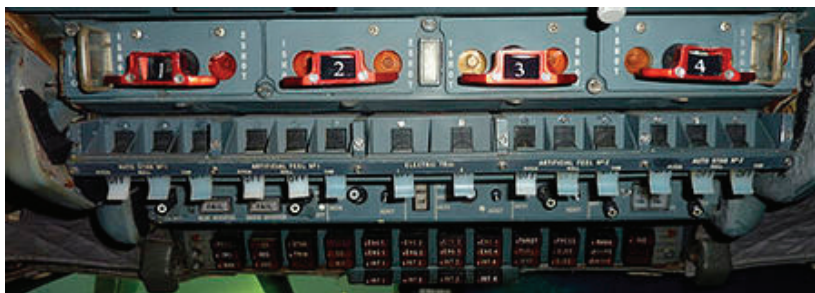
Pull in case of fire

The four red Engine Shut Down Handles, located on the forward overhead panel of the flight deck. Each handle was pulled to ensure that the associated valves would close correctly. *Photo: Heritage Concorde*

Example 2: for various engine fault warnings, including engine fire, the associated Engine Shut-Down Handle (ESDH) illuminates red; under these conditions the engine would have to be shut down and a further 10 valves closed in order to isolate that engine bay from fuel, oil and air ingress. A single pull on the ESDH shuts down the engine and closes all associated valves. The acceptance team would physically check that all of those valves did, in fact, run to their shut positions.

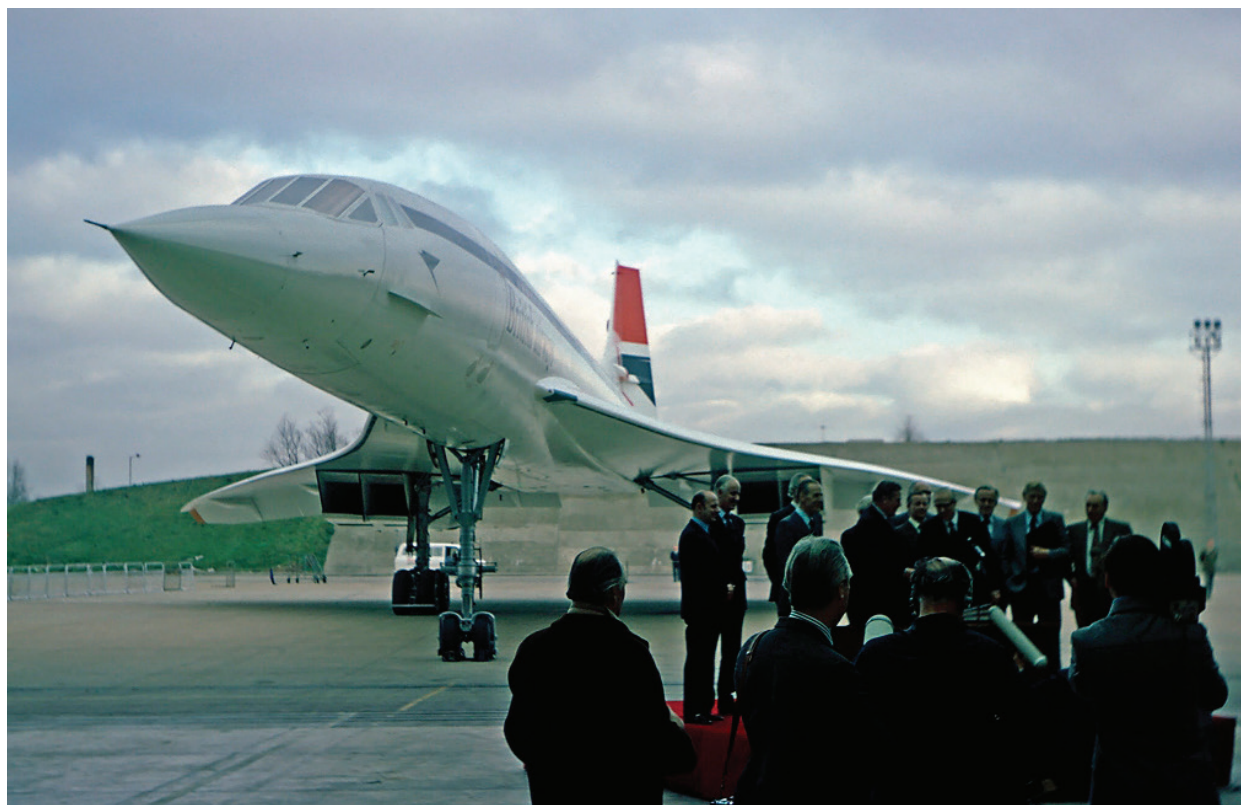
Acceptance flight for Concorde G-BOAE

Alpha Echo (Concorde no. 212) was delivered to British Airways on 20 July 1977. Here, David Macdonald shows the flight plan and map for one of the acceptance flights, which took place on 18 July.

We flew from Filton to Radstock and on to waypoint (wpt) 2, Hartland Point in north Devon, then to 73West in the Irish Sea, to facilitate a supersonic run down to wpt 4; into the Bay of Biscay to wpts 5 and 6; then north-west to 7 and back south to 8, which is the same geographic location as wpt 4. Similarly, wpt 9 is the same as wpt.5.

The INS display 'memory' can only hold nine waypoints at a time; so, having got to wpt. 9 we have to re-program the INSs, so new wpt 1 is the same as old wpt 6; 2 the same as 7; but new 3 is the same as old 3.

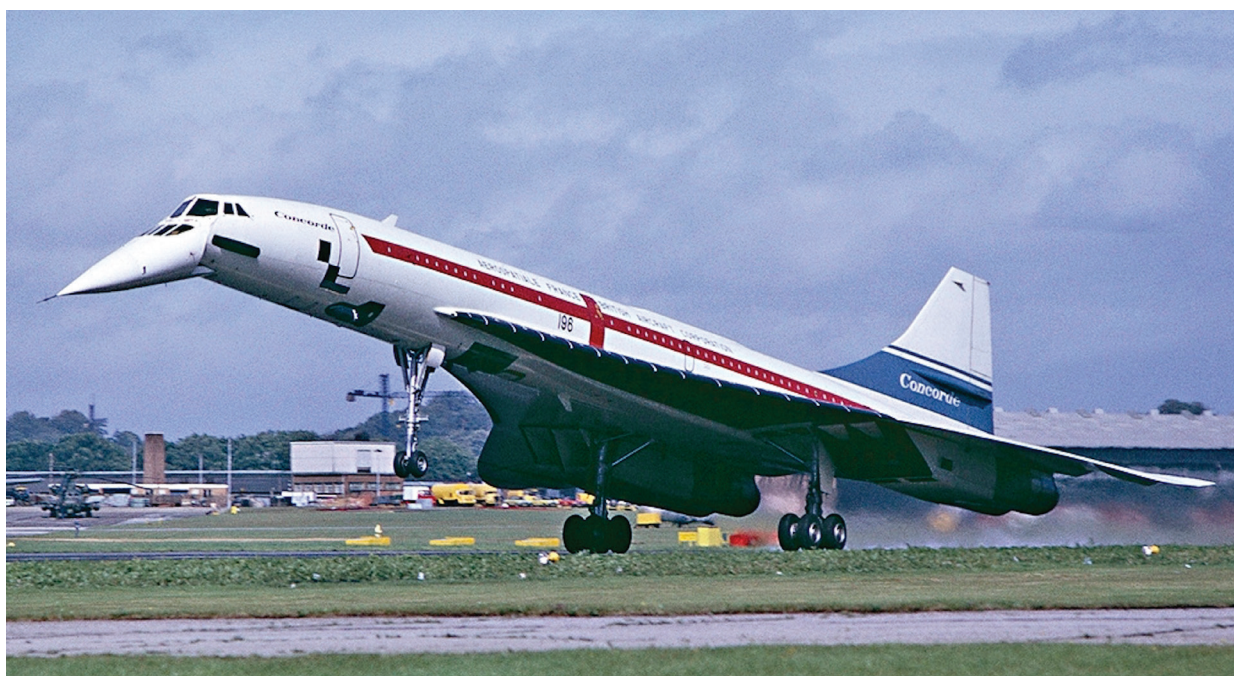
A work-horse on display

September 1974: G-AXDN takes a few days away from the test programme to perform displays at the Farnborough International Air Show. The test markings for the forthcoming ice trials are visible under the canard and the wing, and around the camera mounted under the forward cabin door. *Photo: Steve Fitzgerald / Wikimedia Commons (GFDL 1.2)*

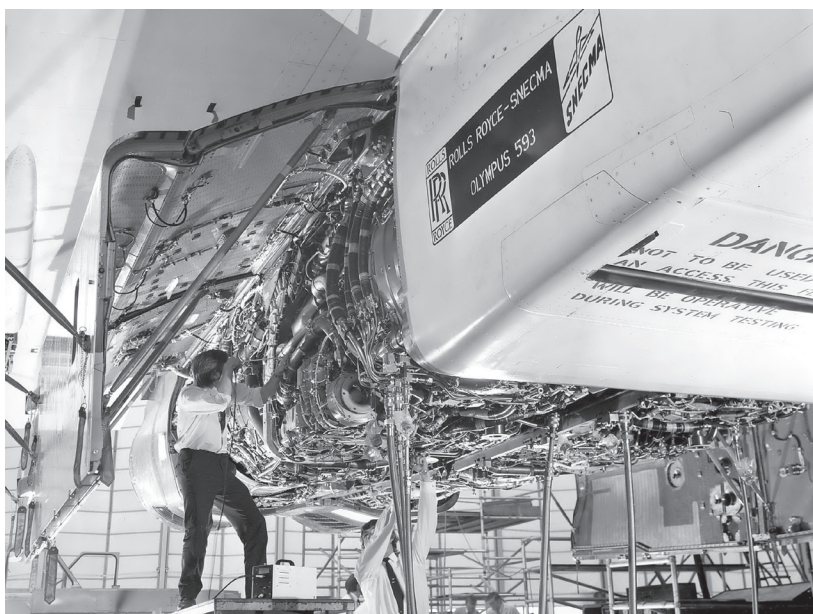
1970: An engineer performs a boroscope examination of an engine prior to XDN's maiden flight. Before the 1974 test programmes began, the aircraft was fitted with the new Olympus 593 Mk 602 engine, which would be used on the production aircraft.

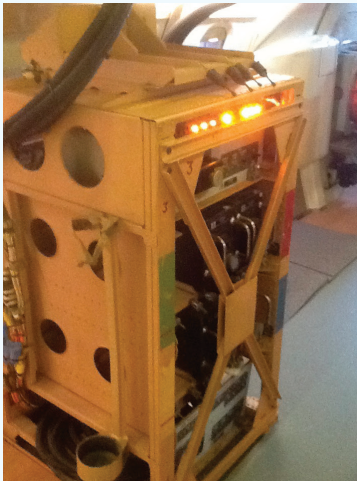
Test flight units
The bulky cabinets holding the first digital Air Intake Control Units, installed in G-AXDN's cabin; these units are still in place today, and have been restored to show how they would have looked while in operation. Photo: John Dunlevy

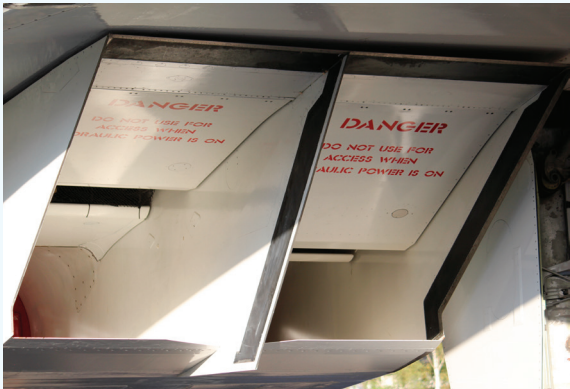
External view of air intakes
The ramps inside the intakes are clearly visible; in this case they have been set at different positions for display. Photo: Tim Sheerman-Chase / Wikimedia Commons (CC BY-SA 2.0)

These ramp doors create and hold a shock wave within the intake, which effectively slows the incoming air and allows the engine to carry on breathing without surging.

The positioning of the shock wave is critical at all times at supersonic speed and must be maintained within a specific band. The action of the ramps is controlled digitally by eight Air Intake Control Units (AICUs). On G-AXDN these were stand-alone units installed in the cabin. By the time the production aircraft had been built, though, the AICUs had been incorporated into the flight-deck controls – two for each intake.

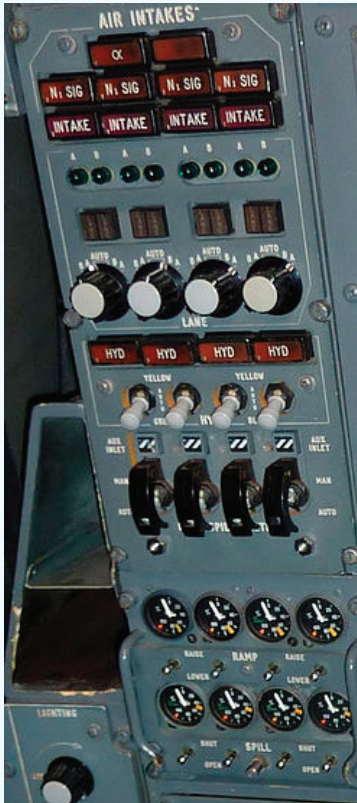
Flight-deck controls
The controls for the AICUs on the production aircraft. These instruments are part of the flight engineer's control panel. They enable the flight engineer to monitor the activity of the AICUs and the movement of the ramps and spill doors. Photo: Heritage Concorde

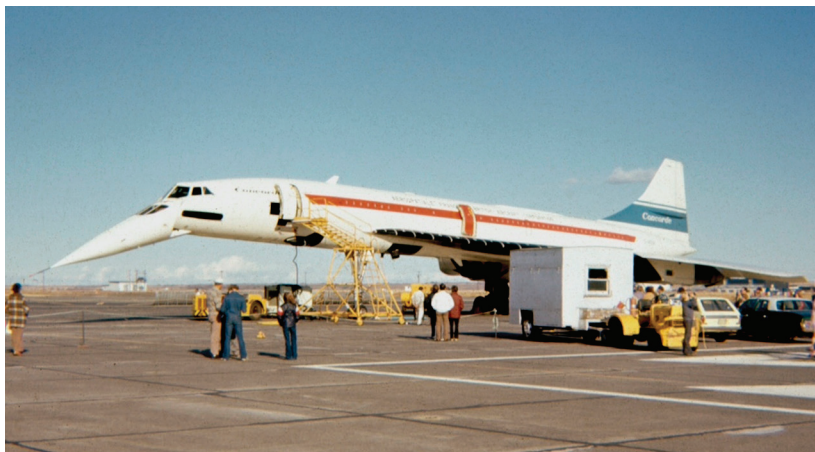
Areas marked for observation

G-AXDN on arrival at Moses Lake; the black paint can be seen on the underside of the port canard, beside the forward cabin door, around the camera (under the yellow steps), and on the underside of the port wing.

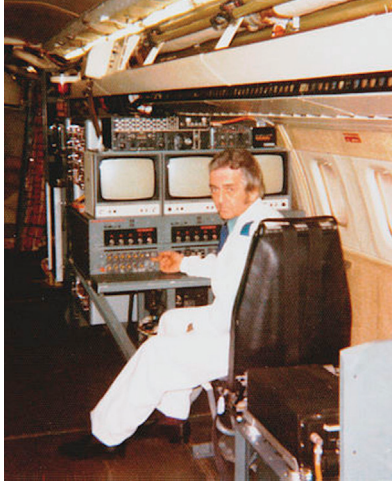
Flight test observer

Alan Radford seated at the Ice Station.
Photo: John Dunlevy

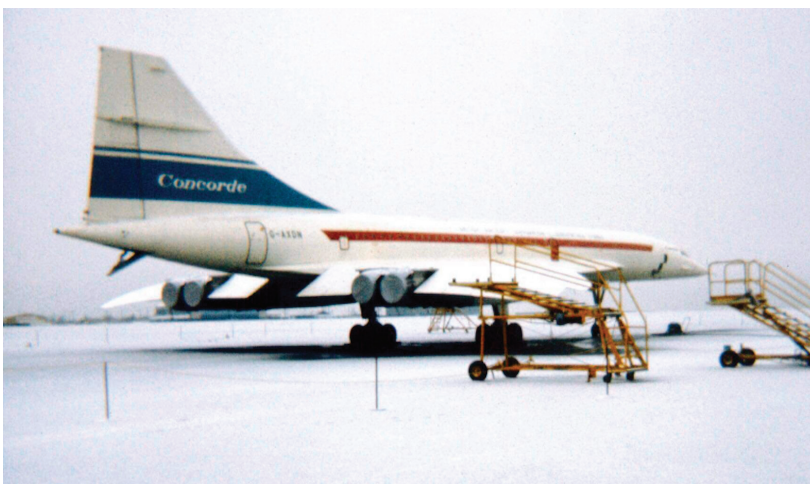
Below freezing

The weather finally became cold enough to provide the icy conditions for the test flights – but the freezing temperatures rendered many instruments and controls immovable.
Photo: John Dunlevy

I had the idea of putting the instrument lighting on full to try and warm things up. After around an hour things looked more promising, except that the warning flags on the exhaust gas temperature (EGT) gauges failed to clear.

Then I pulled the control column and found it almost immovable. On investigation, to our horror, we found ice around the bell-cranks in the dry bays due to moisture condensing there overnight. This necessitated the use of a ground air start truck to blow hot air around.

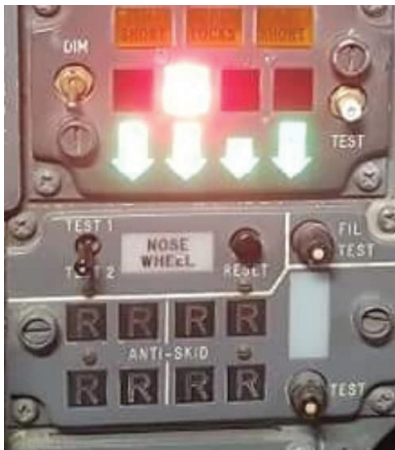
Landing gear lights

The four landing gear lights now correctly show as 'down'; the tail bumper light is the small one third from the left. The red light indicates that the nose gear bay doors are open. *Photo: Graham Cahill*

James repaired the tail bumper indicator, which was showing as 'up' but was actually down. This issue originally arose because when G-AXDN arrived at Duxford she was stored outside, so bird nets were fitted; the only way to fit the net was to cut a wire loom to the tail bumper, which caused a false indication of 'tail bumper up' on the flight deck. This has been resolved, but the wiring loom has not been reinstated.

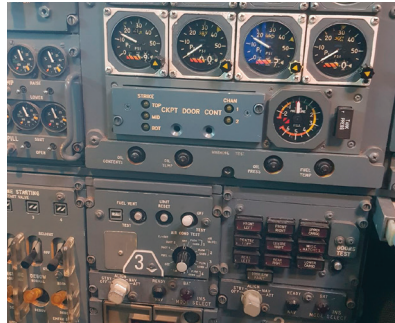
Cockpit door strike panel

The unit fitted in its proper place (just beneath the four dials).

Replacement of cockpit door strike panel missing from engineer's panel, and replaced by a previous engineer with a headset unit moved from the 5th position. The RVP very kindly obtained the correct unit for us; they are extremely keen to see OAC in tip-top condition and made real efforts to get this part for us.

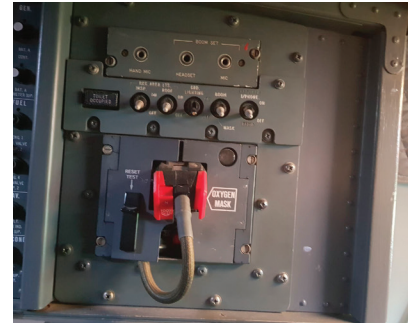
Headset unit

The unit restored to its original place (above the row of switches).

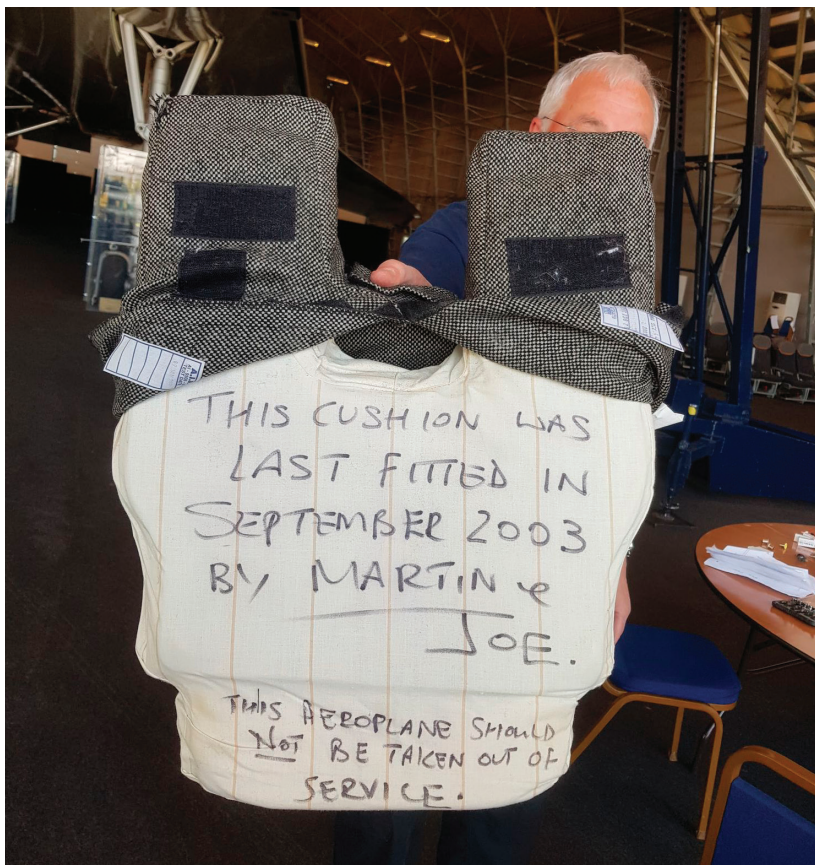
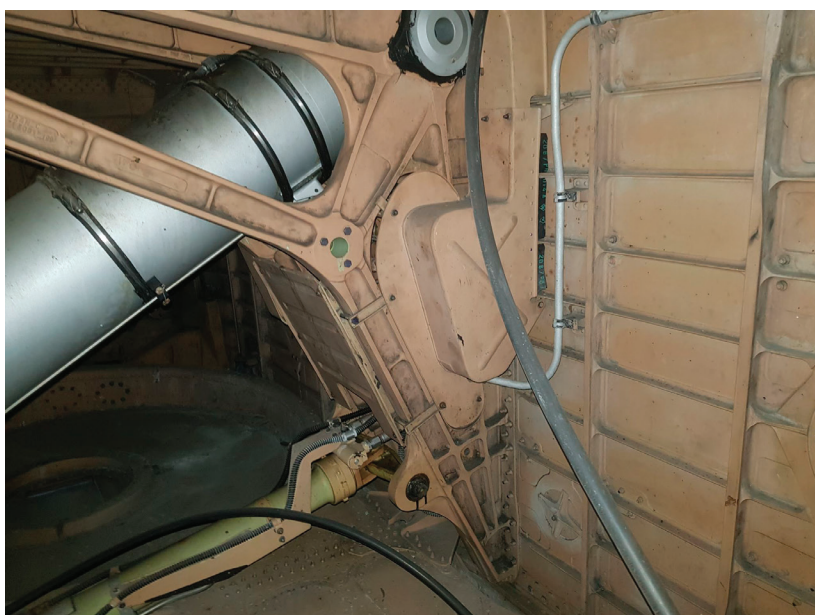
Main landing gear bay

A view inside one of the landing gear bays, with one of the struts for the leg visible. The interiors were in good condition.

I inspected the main landing gear bays. It was nice to see untouched parts of the aircraft. I was replacing filaments in there anyway so took a full look around. All was OK and in great condition.
