MACH 2

Concorde
magazine

Issue 31
August 2021

RE-PAINTING ALPHA GOLF

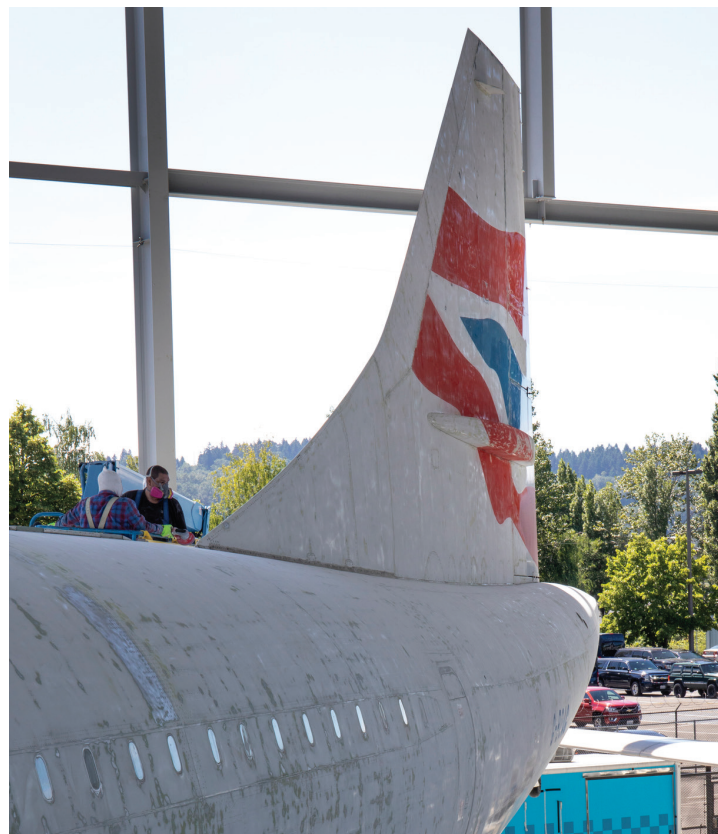
Heatwave conditions

Right: A worker sands Alpha Golf's tail in the summer heat.

It took days of prepping and sanding to remove and smooth worn areas on the plane. The sandpaper was all “hook it”, with holes to accommodate the vacuum bags. It was sanded deep enough to provide a smooth solid surface for the paint, while bare and thinly covered areas were primed.

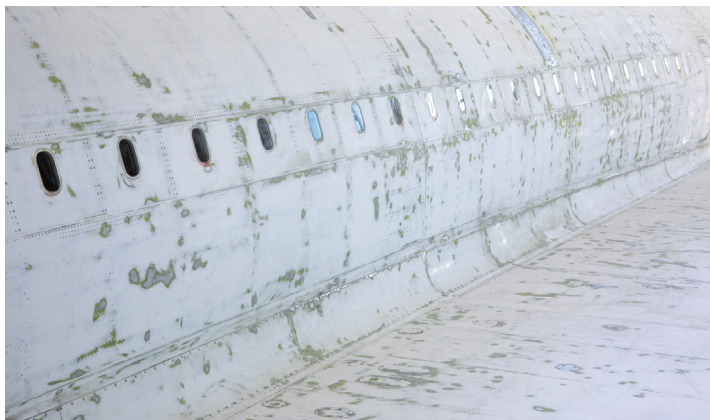
Preparatory work
Above: The fuselage and wings, after many days of sanding and priming work.
*Photo: Ted Huetter/
The Museum of Flight*

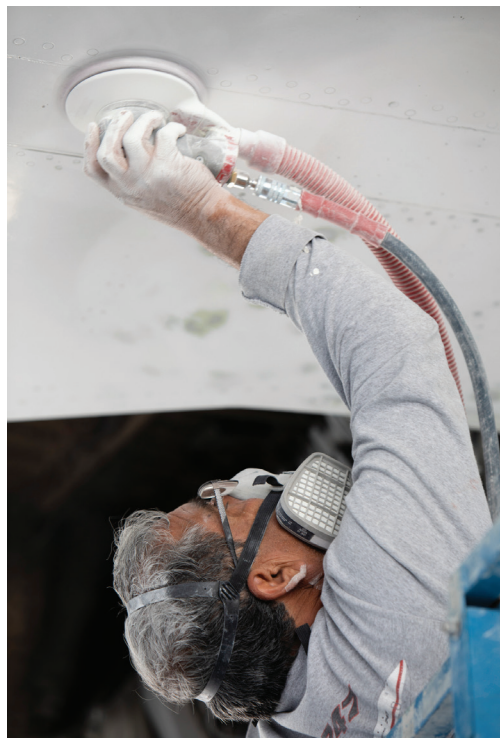
Minimising dust
Right: A worker sands the underside of the aircraft. The vacuum tube for collecting the dust can be seen attached to the sanding pad.
*Photo: Ted Huetter/
The Museum of Flight*

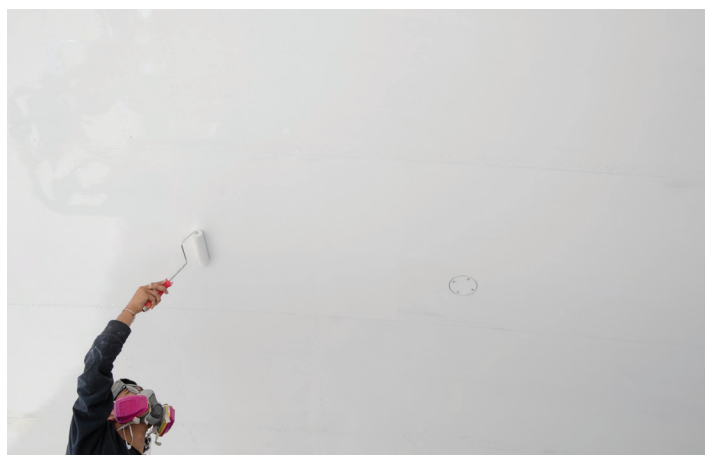
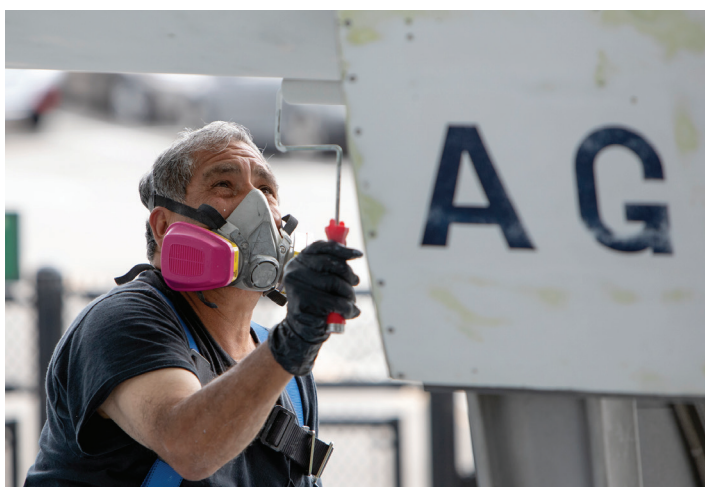
Painting in progress
The aircraft had to remain in situ and could not be sprayed, so both large areas (top) and small corners (above) had to be painted by roller.
Photos: Ted Huetter/The Museum of Flight

The biggest consideration for the paint crew was that Alpha Golf had to be painted where it is in the Aviation Pavilion. Environmental concerns meant it couldn’t be sprayed. All of the preparatory sanding had to be contained in vacuum bags, and the paint had to be rolled on. “That is always a shock when people hear about it or witness it,” said Amico.

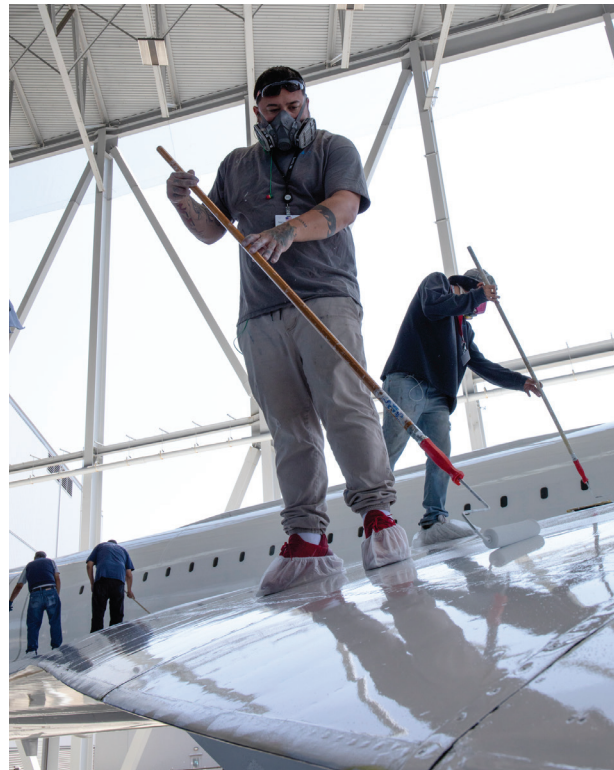
Painting the wing

Above: Several crew members work together on the wing.
Photo: Ted Huetter/The Museum of Flight

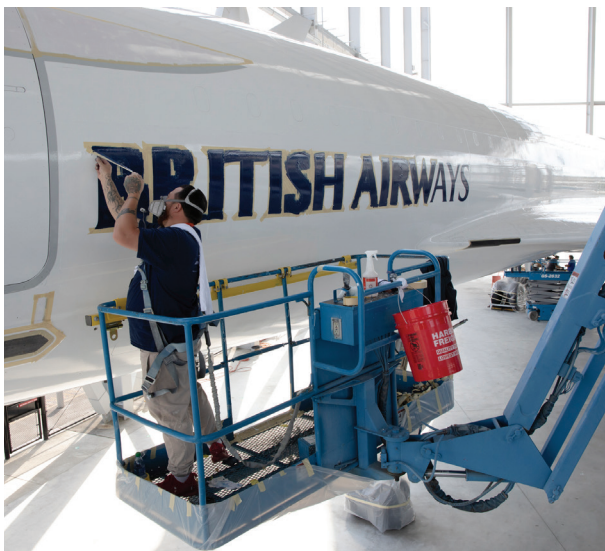
Applying the lettering

Left: The protective tape around the newly re-painted lettering is carefully removed. The Speedmarque is still to be done at this point.
Photo: Ted Huetter/The Museum of Flight

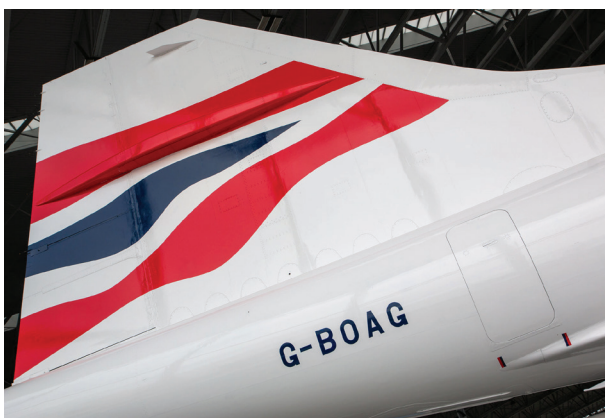
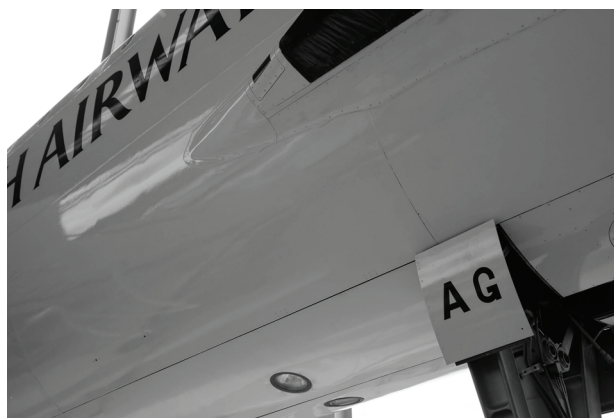
Adding the final touches

Below left and below: The British Airways livery and Alpha Golf’s registration have now been added to the paintwork. The very last touches, notably the decals to give the “fade” effect on the livery and the Speedmarque, will be added over the next few weeks.
Photos: Sean Mobley/The Museum of Flight

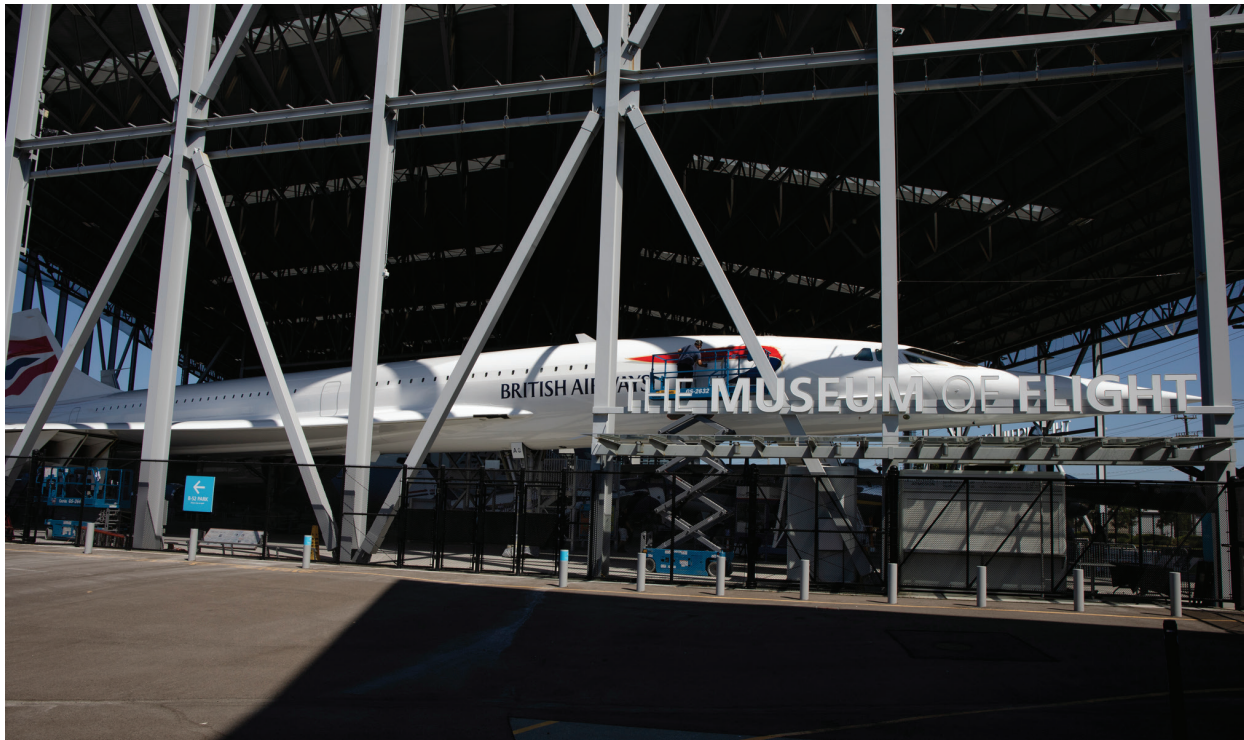
Preparation for display

Alpha Golf, almost ready for display again. Even at this stage the aircraft looks much better for her new coat of paint.

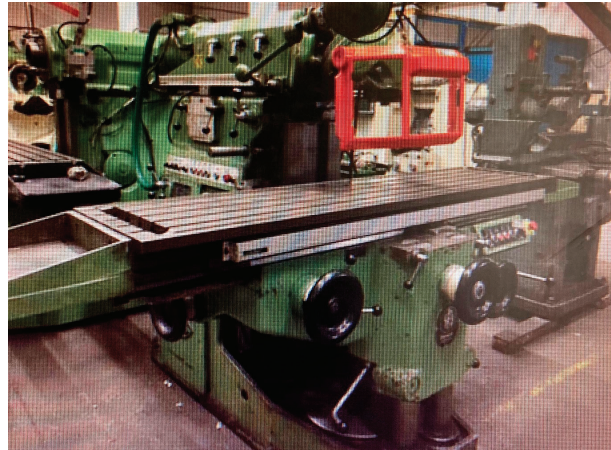
Huron Mu6

The machine was operated by means of automated instructions typed on to a teletape and fed into the machine's control box.

In the main workshop a Huron Mu6/Mu66 milling machine had been installed by Rudolph Carne of Isleworth, Middx. The machine was all new, NC (numerically controlled). In this process, very new at the time, the instructions for the machining process were typed on to punch tapes, which were fed into teletype machines. A special office was erected in the workshop where the teletype machines were installed and guys were punching in co-ordinates for the machine to cut profiles. The rolls of punch tapes were then loaded onto reels in the Huron's control box and the cutting of a Concorde profile was started.

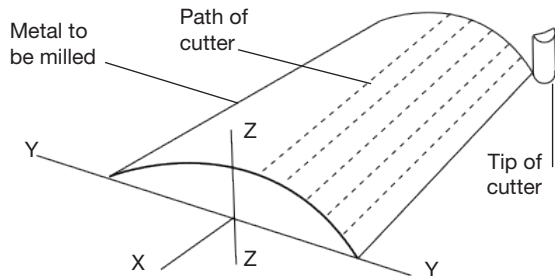
Cutting path

The tips of the cutters (bottom of image) had to be re-ground repeatedly to keep them sharp.

The diagram above shows the path that the cutters would follow as they shaped the metal.

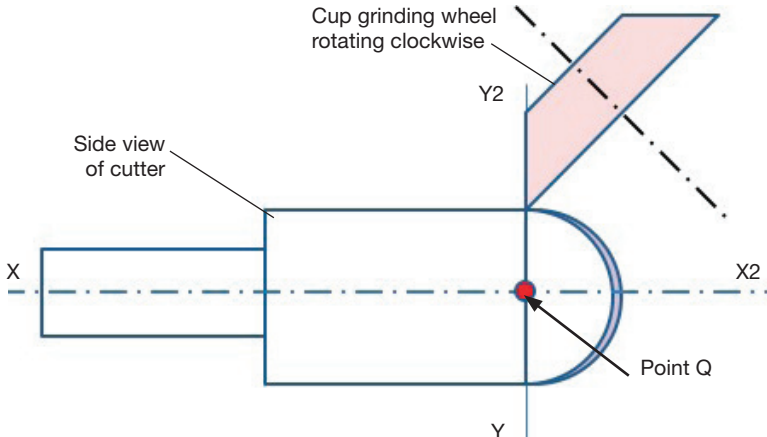
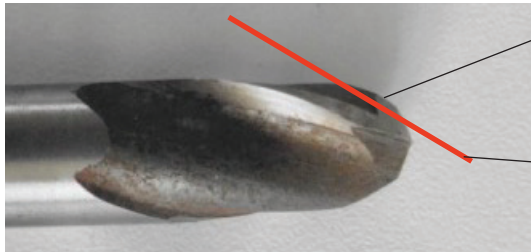
Details of the process

Top: Side view of cutter, with the position of the cup grinding wheel shown. The grey area is the area that the grinding wheel will remove.

Above: Detail of the cutter end, showing area to be ground away.

- Once the cutter was secured in the fixture, the cutter was indexed across point "Q".
- The cup grinding wheel was set as shown.
- The fixture was turned 90° between Y2 and X2.
- The cutter was then turned through 180° and the same operation was repeated.
- Also, I lowered the cup grinding wheel to give an 8-degree clearance to the cutting edge.
- In addition, I used free hand grinding behind the cutting edge to help in releasing swarf.

It was Dad who pointed out the need for the cutter to be passed over point Q. Also, his knowledge of materials and cutter clearances during mass production solved the over-heating of the cutting edge.

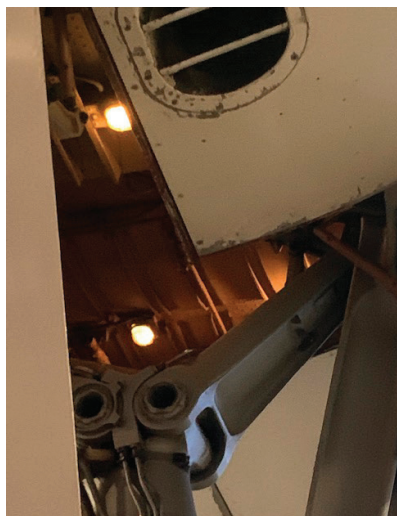
Lights in service area

A view of the service area in the nose leg bay, now lit by LEDs.

We replaced all the 28v dual filament lamps with similar glass LED lamps; in order to preserve authenticity the original colour temperature of the replacements was the same as in the originals. This work has now been completed and visitors will now see the service lights in

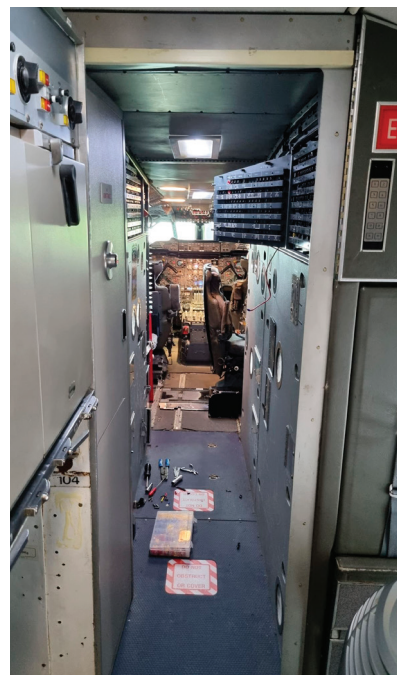
Work in progress

Connecting the 115v power supply. The team connected the supply to the existing circuits so that the lights can be run from the aircraft's own systems.
Photo: Heritage Concorde

We purchased a small 115v power supply, which will be used to power the cockpit lighting, navigation lighting (excluding strobes), and landing lights. Other items may be added in the future; these will be selected by John Dunlevy.

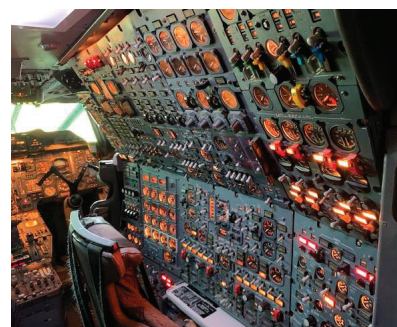
The finished result

Instrument lighting now operational. The team were very pleased with the results and hope that this work will add to the impact of the aircraft tours.
Photo: John Hepple

Cockpit instrument lighting makes a huge difference to the cockpit and the offering at Manchester for technical tours. The best way to complete this work was with the application of 115v to existing circuits and using the aircraft's own systems to power the lights rather than removing transformers and applying 5v direct to the instruments (as done on Concorde at other locations). The wiring was tested, and we applied 115v to the individual circuits; the instrument lights work really well and look fantastic.

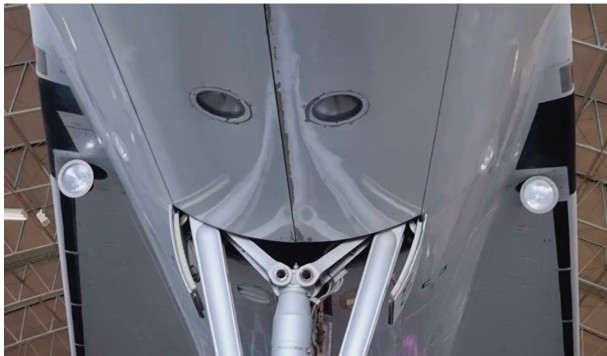
Landing lights lowered

Work is being done to reactivate the lights but with LEDs, which will save energy and produce less heat than the original lamps.

We have started work on activation of the landing lights. This will use all of the original systems; however, the lamps will be replaced by LEDs, which will produce less heat and last much longer. (The original lamps will be retained in case they ever need to be put back.) This project is very much ongoing, and as

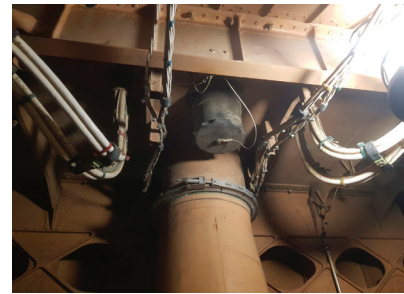
Air conditioning ducts

The team are looking at using G-BOAC's own system to provide cooling on board the aircraft.

You would not believe how hot it gets in the cabin of G-BOAC in the summer months. As you walk up the stairs to the aircraft you can feel a significant increase in heat, due to the hot air being trapped in the hangar. We are looking at a cooling solution that will move air from the lower, cooler part of the hangar to inside the aircraft using the original air conditioning ducts within the aircraft. Although this work is in its early stages so far, things have been positive and we will report further on this in the next issue.

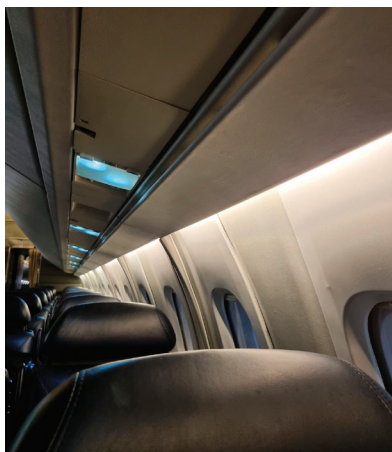
Cabin lighting

The new LED lighting in place on the port side of the cabin.

On G-BOAC, the cabin lighting consisted of 240v fluorescent tubes, which were installed in 2003. From almost day one these started to fail and were regularly replaced by the RVP; however, as time has progressed the RVP has found it much harder to obtain the tubes to fit, and where they could find them they

We are in the process of replacing the tubes with a low-voltage LED replacement. Currently we have completed the port side forward cabin and are working on the starboard side forward cabin; because tours are constantly running currently, we have a mix of LED and original tube lighting. Once the project is complete, the whole forward cabin will be lit by LEDs with a colour temperature correct for the period. The benefits of this change will be less maintenance for the RVP, less heat generated, and more light, as all the lighting will work. We can't wait to see the finished result in the forward cabin, which should be complete by the next issue of Mach 2. The project so far has been funded by Heritage Concorde.

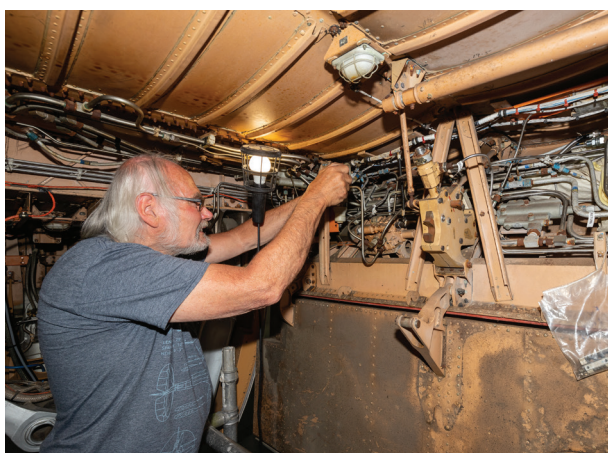
Working in the nose landing gear bay

Former Concorde engineer Peter Ugle disconnects Green hydraulic system connections for the nose wheel steering.
Photo: James Cullingham

On 17 May and 9 June, progress was made with a project to install the hydraulics pump in the nose gear bay – a set-up effectively identical to that used for G-BOAF – to remove the need to have pipes running underneath the aircraft. Work involved fixing the ground door opening system, which was eventually (after some head scratching) traced to the cut wires on the tail skid. The wiring has now been corrected and the solenoids work as expected. Pipework was also identified and work started to find the correct fittings.

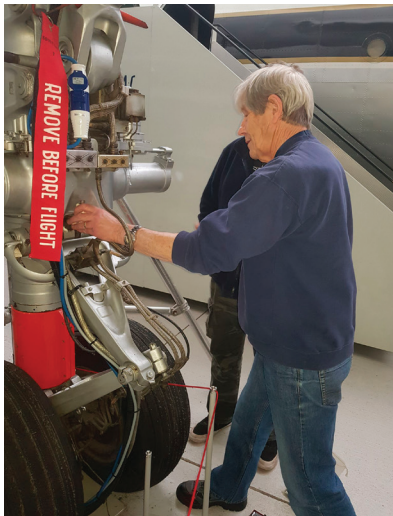
Planning routes for cabling

Former Concorde engineer John Dunlevy assesses possible routes for the power cables to the pump.

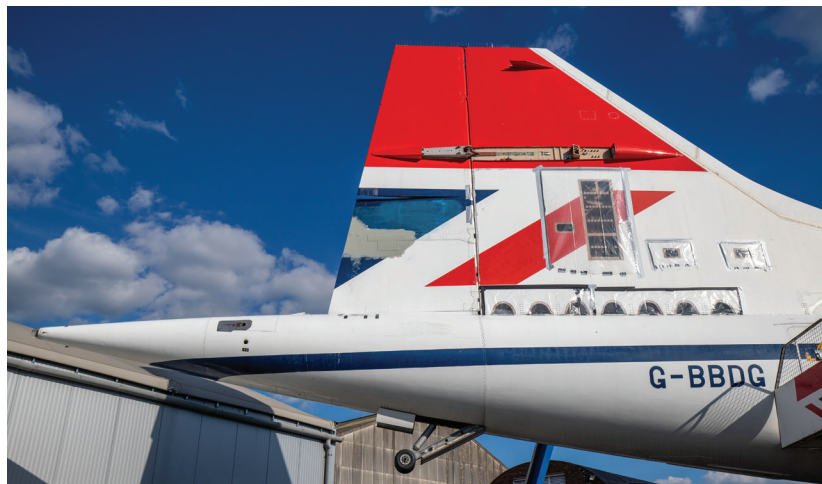
Work on the tail fin

- The tail fin, up to the kink in the leading edge, was sanded ready for treating and painting the following weekend.

- Further progress was made on repainting the tail.
- A number of panels were sanded back, treated and repainted.
- A number of sections on the airframe had the same treatment.
- Panels completed the previous week were re-fitted and sealed.

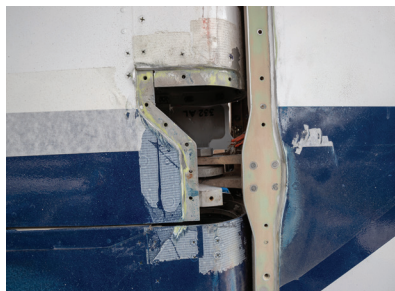
Upper rudder, bottom hinge

Hinge cover and seal strip seating areas prepped ready for painting.

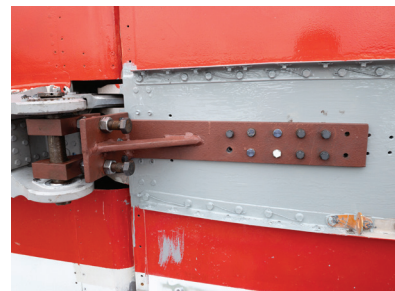
Upper rudder restraint bracket

Newly manufactured bracket allows either rudder to be independently held for painting and enables the use of a smaller upper-lower joint plate.

● Carried out a final fit of the new upper rudder bracket.

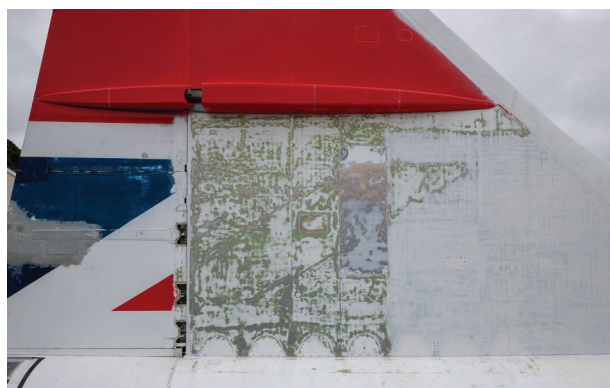
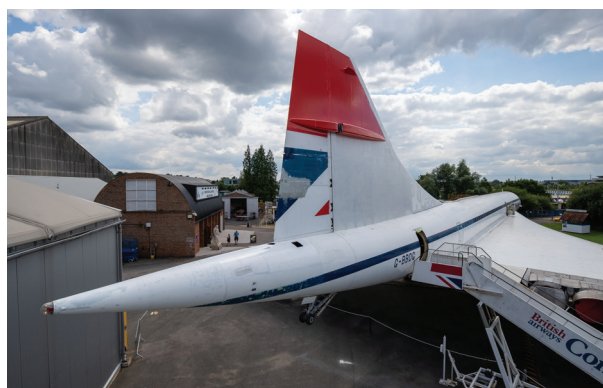
Below left: Right-hand tail fin with panels refitted and sealed and bare metal treated, ready for undercoating. Below: Undercoat done on right-hand fin and upper fuselage from mid-way along the rudders to the rear tail light.
