MACH 2

Concorde magazine

Improving on
excellence
Concorde modifications

Issue 35
August 2022

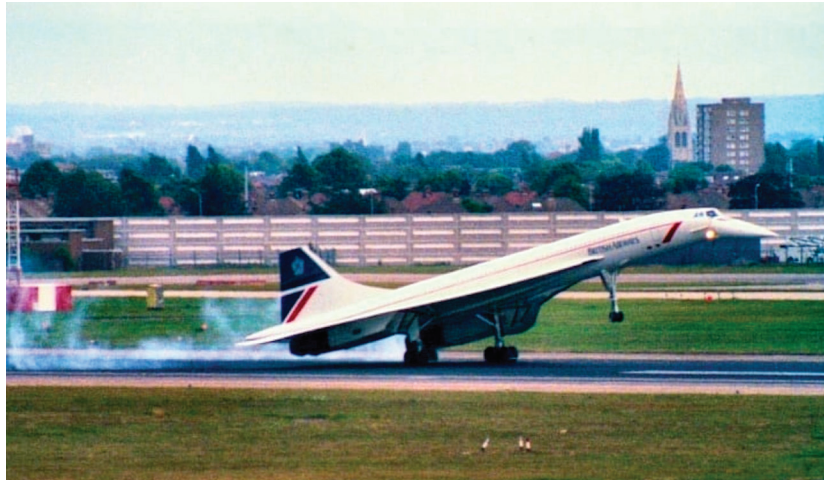
Main landing gear

Above: The main landing gear.

Right: Concorde landing, showing the pressure that the gear had to bear.

Concorde's general shape, and that of the Tupolev Tu-144 (and of every nascent design since), is a slender delta – that way efficiency lies. In this case the long, narrow fuselage (high fineness ratio) is at odds with, of all things, the landing gear – in particular, the main landing gear – in fact one huge shock-absorber; it has to deliver a

The stiffness of the main landing gear allowed the forward fuselage to go into vertical and lateral oscillation at the fuselage's natural frequency; the effect would continue for as long as the aircraft's weight rested on its undercarriage, only ceasing when we were airborne and the weight was now borne by the wings. On the flight deck one certainly felt the undulations, but the vibration made it more than a little difficult to read the instruments. It was certainly a relief to get airborne.

gear units had been designed to a particular degree of stiffness, perfect for most runways but not for those with a less than perfect surface; therefore, the main gear internals were modified to soften the spring rate and ease the friction, thus effectively preventing the vibration. Since we visited something like 375 airfields worldwide, the mod was well worth while.

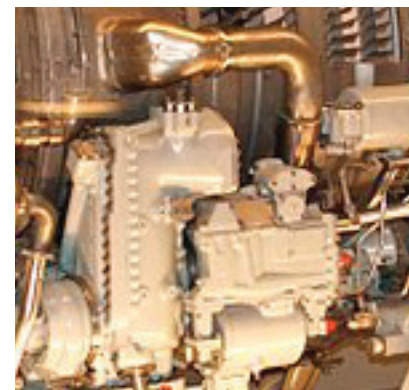
Location of the SSP and FCU

Detail from a display specimen of the Olympus 593 engine. The large, light-coloured component just below the right-angled pipe, just right of centre in this image, is the Flow Control Unit (FCU). The Second Stage Pump (SSP) is behind and attached to the FCU.

By now we had three ‘suspect’ SSP/FCU assemblies. All were separated, stripped down, inspected, measured and rig-tested by their manufacturers. Nothing was found to be wrong; not the slightest anomaly. What we did know, though,

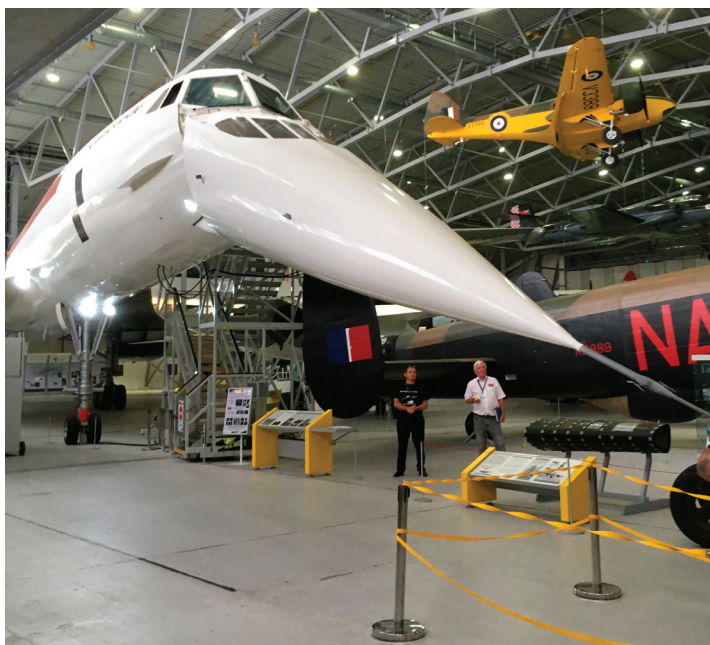
Still looking gorgeous
G-AXDN with nose and landing lights reactivated.
Photo: Katie John

At 12.15, we had a demonstration of G-AXDN's current capabilities. After audio of an engine start-up, Simon Peachey of DAS carried out a nose move (prompting a gasp of excitement from some watching schoolchildren). The navigation, anti-collision and taxi lights were also switched on to provide a full “back to life” display.

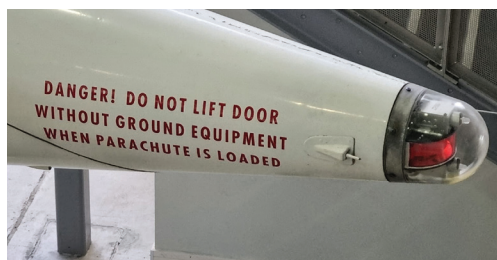
New decals
Below and right: The original decals on the airframe have been replicated exactly.
Photos: Heritage Concorde

Graham pointed out the new decals – exact replicas of the originals – that DAS had had applied by a local signwriter, plus the replica “bonkers” on the tail and wings. G-AXDN is looking in fantastic condition – a tribute to DAS and their painstaking care.

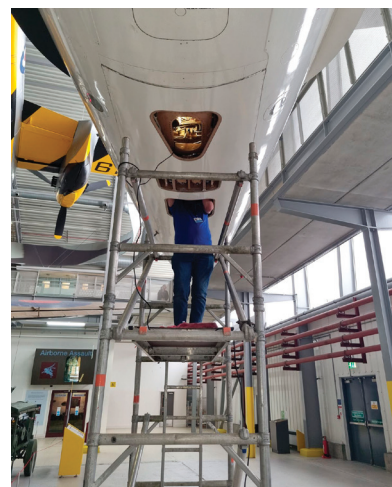
Nose system

Peter Ugle fixing the connection on the nose jack to stop the leak.

A small leak developed on the nose system; the leak was quickly solved

by tightening of a connection to the nose jack on the 12.5 degree side. (In the case of G-AXDN it is literally the 12.5 degree side of the jack, as production aircraft have a 7.5

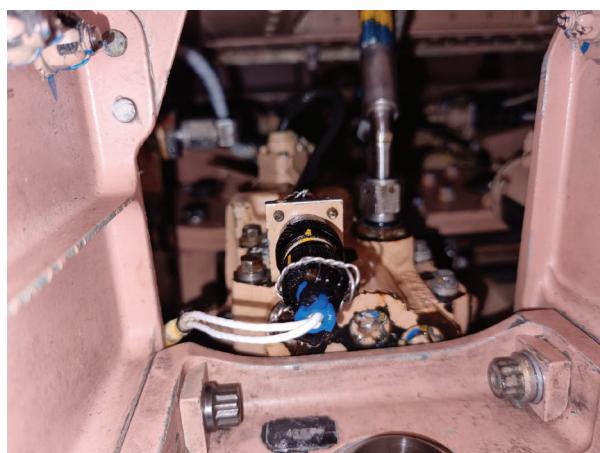
Nose system leak

The 12.5 degree nose jack; the vertical pipe just right of the centre of the image was the one that had the leak fixed.

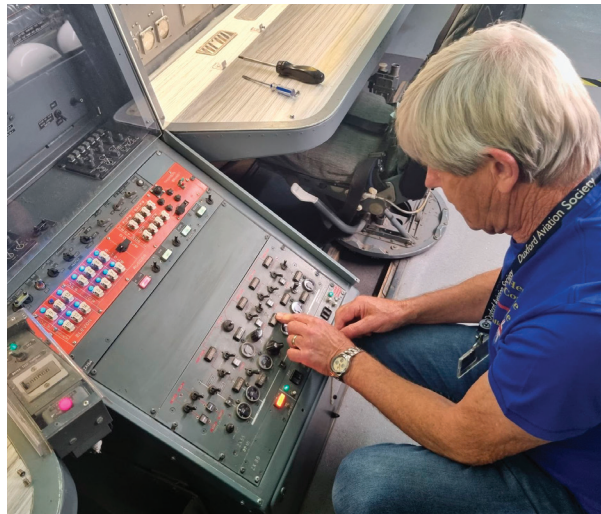
Flight test observer's station

John Dunlevy replaces light bulbs on the flight test observer's station in the cabin.

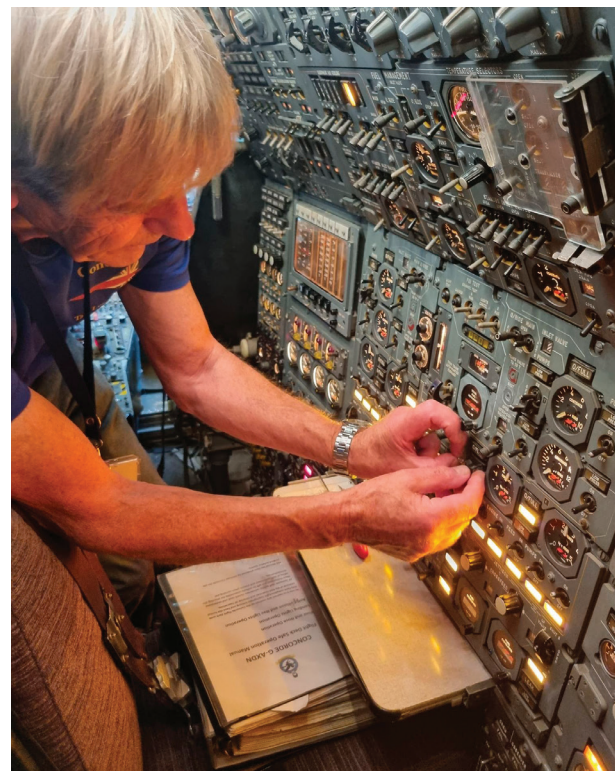
Flight engineer's instrument panel

John Dunlevy adjusts the lighting on the instrument panel to look the way it did when G-AXDN was in operation.

As outlined in the previous edition of Mach 2, we were completing improvements to G-AXDN's general visitor lighting in the cockpit. We had already completed the dash panels; this time, the engineer's panel has also been completed. The finished product looks great in comparison to what was there before. We have copied original lighting

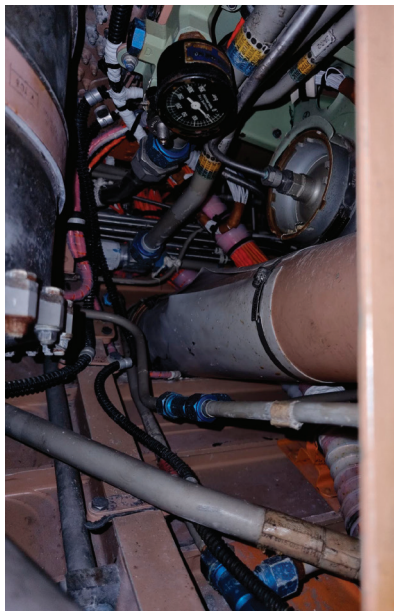
Brake accumulator

The brake accumulator in the rear of the aircraft, with the power being discharged; the unit has now been made safe.

We found in the rear of the aircraft a brake accumulator that was still holding 150 bar of pressure. It has been 40-odd years since G-AXDN retired and we were surprised to find this still charged after such a long time, but for safety reasons no original pressurised containers are required on the aircraft and part of the decommissioning practice is to remove or discharge such vessels. We were sad to do this, but we safely discharged the accumulator (following the procedure from the maintenance manual) once the museum had closed.

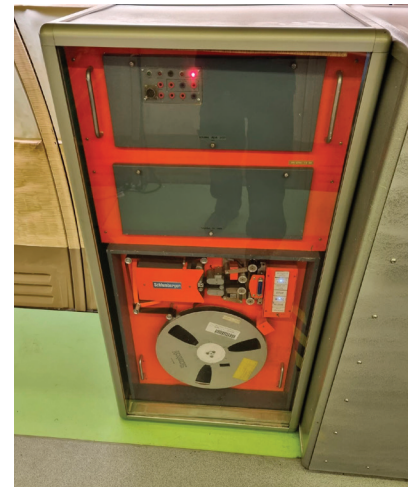
Data recorder unit

The replica tape recorder unit in the cabin; this unit would record data from test flights for analysis after landing. The unit can be switched on to show how it would have worked during the test flight programme.

Regular maintenance of the displays on board G-AXDN was carried out. The most significant was repair of the tape unit, which had become faulty. The unit is a copy of a data recorder used to save data to a tape during test flights, and as it has moving parts it requires regular work. The tape unit can now be switched on daily. This work all adds to the visitor experience.
