MACH 2

Concorde magazine

Issue 47
August 2025

From tragedy to resurrection

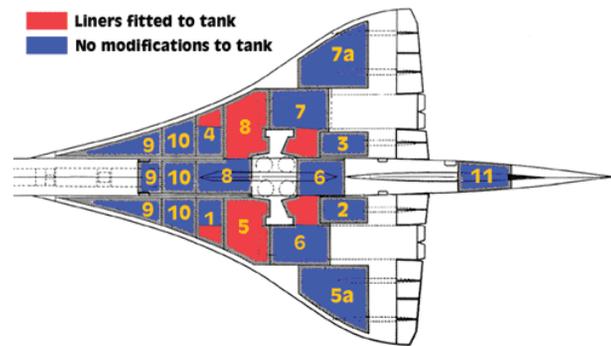
Modified fuel tanks

Tanks 5 and 8 would be fully lined, and linings would also be fitted to parts of tanks 1, 4, 6, and 7.

Moulded "egg crate" linings made from Kevlar, impregnated with a waterproof sealant called Viton, were created for fitting to the tanks considered to be most at risk from being hit by debris, as had happened in the tyre burst on F-BTSC. If a fuel tank were to rupture, the liners would be sucked into the hole and plug it, reducing any fuel loss to an estimated 0.4 litres per second. It was also thought that the Kevlar would dampen any shock waves arising within fuel tanks in the event of debris impact.

On the basis of the computer modelling results, the team opted to fit linings to the areas that were most at risk of impacts from debris, rather than lining all of the tanks. The linings had to be individually shaped for specific areas of each tank. In addition, each aircraft was slightly different from the others in build, so the liners had to be shaped accordingly. Some had to be returned to EADS in Toulouse for re-modelling so that they would fit.

The linings were shaped like shallow trays. The bases were fitted between the internal spars of the wing skin, and the sides were bolted to the internal structure. The size and the spacing of the bolt holes were pre-determined by the design engineers at EADS. The base of the liners actually sat a few inches above the skin of the tanks; in addition, the liners were perforated, to let fuel flow through them. This allowed the fuel to be used as a heat sink for the wings, as was normal in Concorde, and to move during adjustment of the aircraft's centre of gravity.

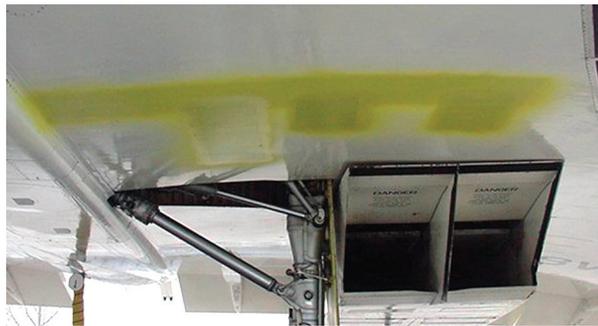
Test area

F-BVFB's wing: the areas stained yellow are the sites where the pipework was fitted for the jets of coloured water.
 Photo: Martine Tlouzeau

F-BVFB performed high-speed runs of between 130 and 180 knots (without reheats), while an inert, coloured fluid was pumped from a 50-litre reservoir to three "exit points" on the underside of the wings, just forward of the air intakes

for engines 1 and 2, so that engineers could study the likely fuel flow patterns and see where fuel flowing from a ruptured tank might come into contact with the engines or landing gear bays. The test engineer on board the aircraft could select different exit points for the water, and the flow patterns were filmed by cameras mounted on the left landing gear leg. The aircraft was also rotated to an angle of 6° for a few seconds, to simulate take-off. The final test, on 1 February, saw Fox-Bravo reach a maximum speed of 205 knots.

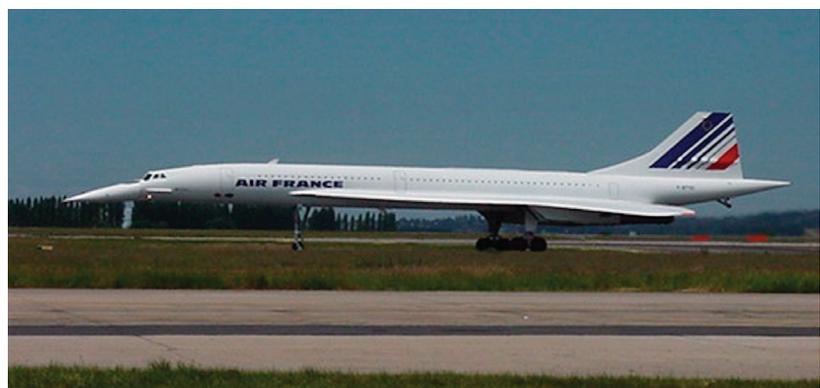
Return from Orly

F-BTSD lands at Paris Charles de Gaulle after being re-painted at Orly. The Michelin NZG tyres were fitted during testing, but the aircraft was flown to Istres and back with the standard tyres. Photo: Martine Tlouzeau

On 2 May, F-BTSD was fitted with a full set of NZG tyres. Flown by Captain Edgard Chillaud, with test pilot Pierre Grange and with British Airways Chief Concorde Pilot Mike Bannister on board as an observer, the aircraft performed two “touch and go” circuits and then a landing with a hard stop. The bad weather on that day served to generate extra data on the way the tyres behaved in wet conditions; the NZG tyres performed extremely well.

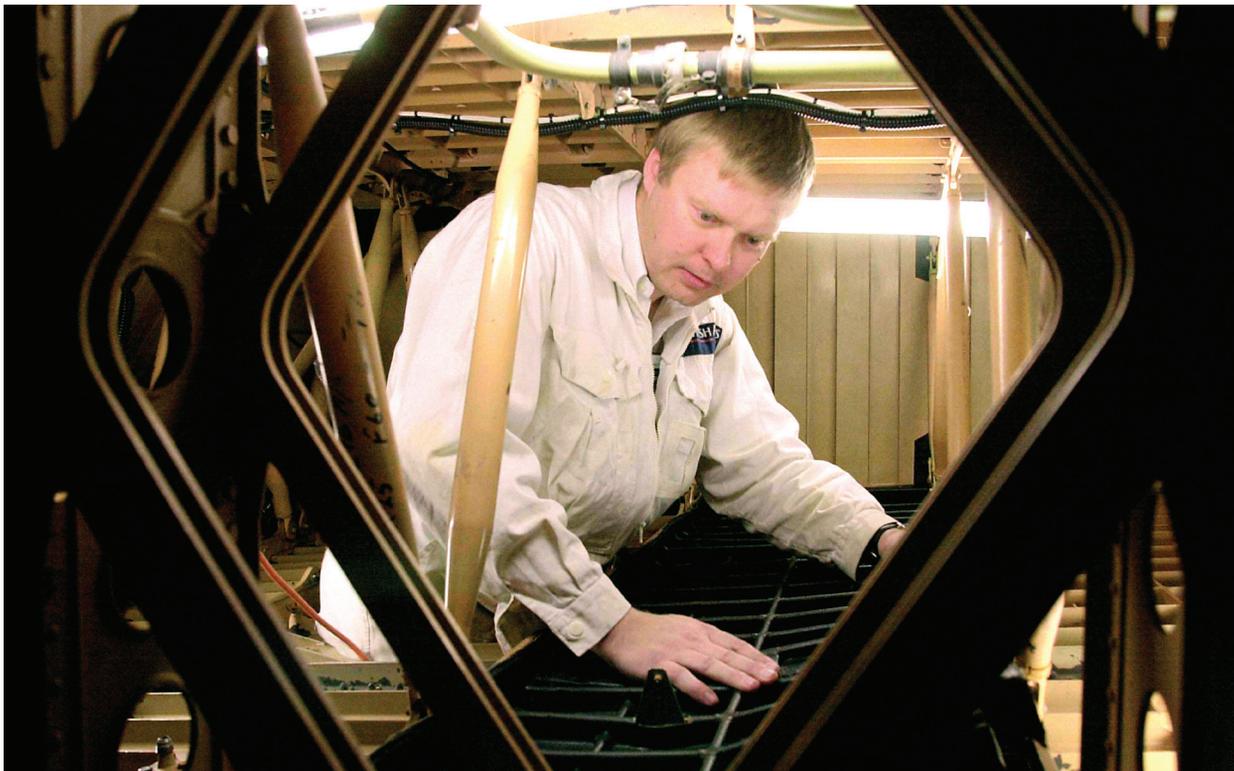
January 2001: Engineer Marc Morley fits a piece of tank lining inside the wing on G-BOAF.

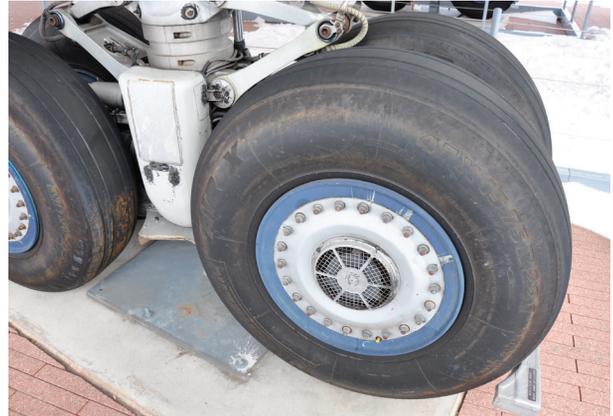
Tyres in place

Above: the new Michelin tyres fitted on G-BOAD. The re-shaped water deflector can be seen at the bottom right of this image. Photo: Jorge Lásca / Wikimedia Commons (CC BY 2.0)

The shape of the new tyres required some alteration to the shapes of the water deflectors, as well as modification to the design of the brakes to give identical braking power to that for the previous tyres.

To give greater resistance to external damage, Michelin's NZG tyre was designed to expand only minimally, hence its name: "Near Zero Growth". Its diameter expanded by only 2% when it was inflated to a pressure of 16 bars (16 kg/m²) and by a further 1% when the tyre was rolling at 360 km/h, giving a total expansion of only 3% at the moment of take-off (compared to 12% for the bias tyre). In these conditions, there was also practically no tension in the tread of an NZG tyre at rotation.

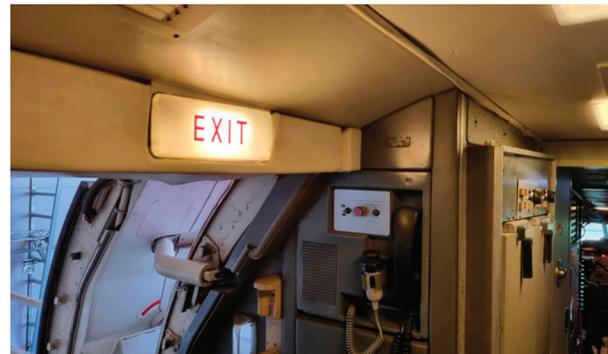
Exit sign

The exit signs over the cabin doors have been restored and are now fully working again.

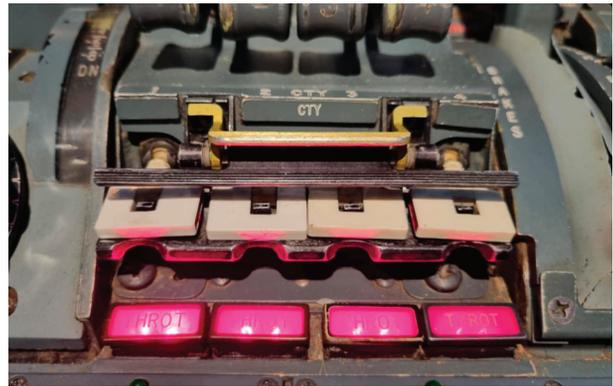
A full set of new switches, from the collection of the late John Dunlevy, has been fitted to replace the broken switches.

We have replaced the reheat switches with new spares from the John Dunlevy spares collection. These reheat switches have been a problem

for many years, dating back to prior to 2011, having been loosened and broken at some point.

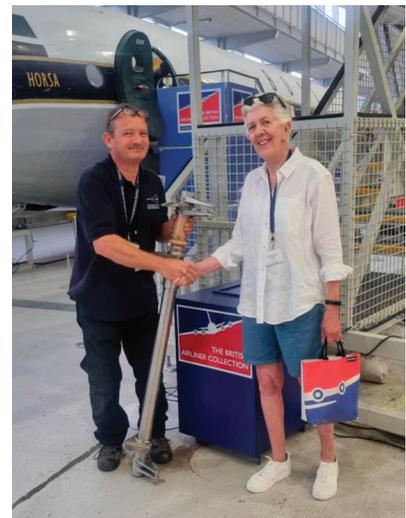
Changes for G-AXDN

Above left: Concorde G-AXDN in the re-organised AirSpace hall. Above: Chrissie Eaves-Walton (right) accepts the torque tube from Graham Cahill (left) on behalf of DAS. *Photos: Heritage Concorde*

We delivered and presented to the Duxford Aviation Society (DAS) one torque tube for G-AXDN's intake restoration. (See Mach 2, May 2025.) We managed to obtain one torque tube for the intake of the aircraft; we still require one more, together with one intake actuator. We will be keeping an eye out for these items. The parts will be fitted to the aircraft so at least one intake will be complete.

The torque tube is the part that moves the ramp doors up and down. There are two in each intake.

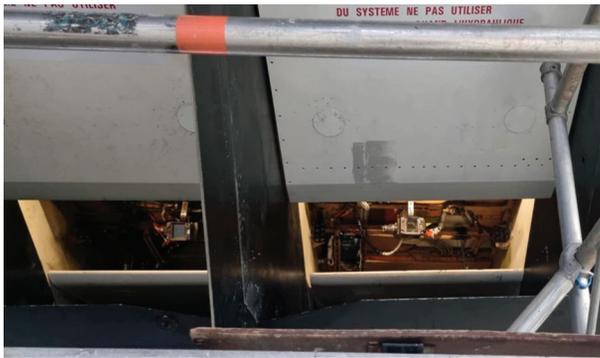
New additions

Left: the cameras installed in the intakes, which have also been illuminated.
