MACH 2

Concorde magazine

Issue 34
May 2022

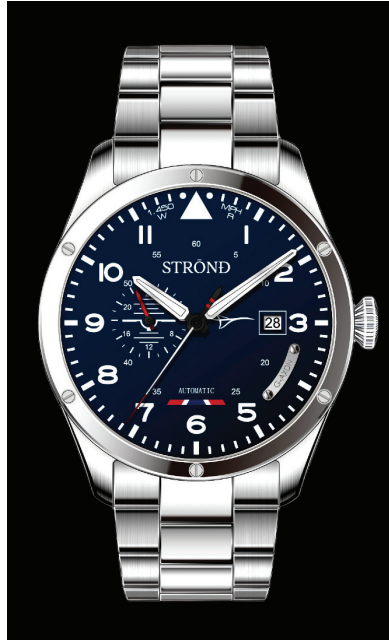
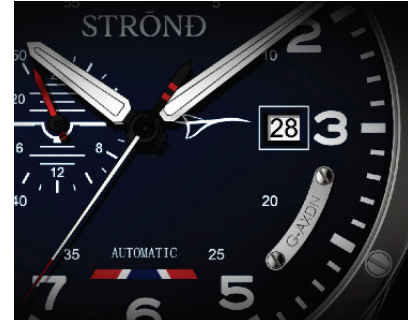
Commemorating 101

Left: The timepiece made to mark the 50th anniversary of 101's first flight. Above: Details of the watch face. The dial tag made from 101's skin, and marked "G-AXDN", can be seen in the 4 o'clock position. A symbol of Concorde, originally designed by Katie John in 2004, is visible just beneath the minute hand.

As a tribute to Concorde 101 and the preservation work done by DAS and Heritage Concorde, Strond has dedicated their new SSC-101 watch to Concorde. The dial tag attached to the face is made from a tiny portion taken from the bottom panel of the air intake. Strond will also honour the aircraft

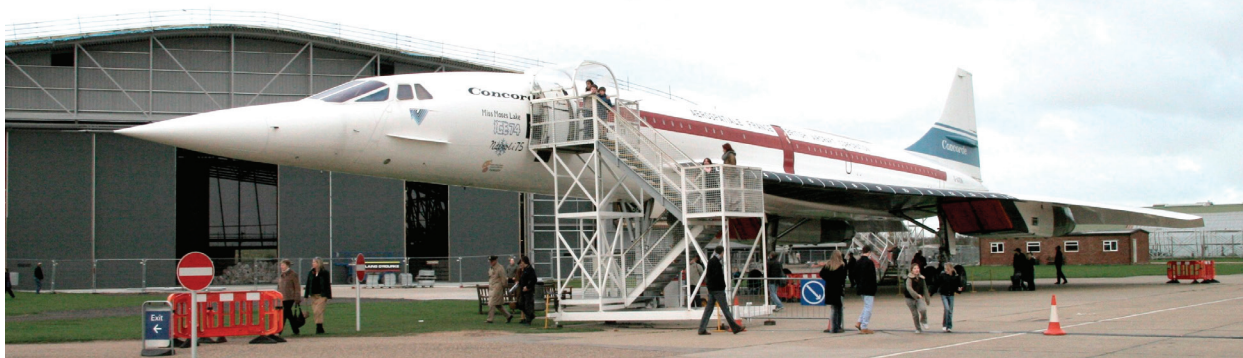
Concorde 101

Concorde stationed outside at Duxford in 2005, while the new AirSpace hangar is being built. The area from where the dial tags are taken is the lower lip of the intake, just visible under the red engine covers.

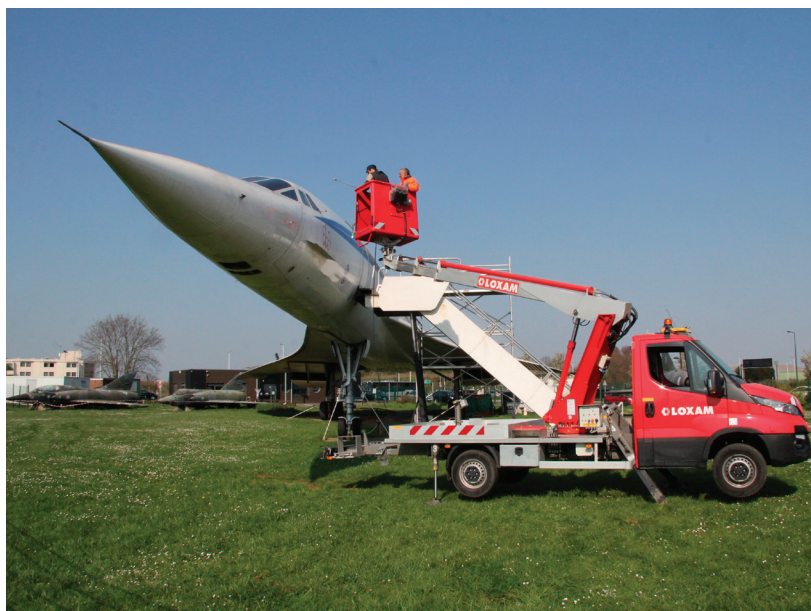
Cleaning vehicle

A mobile platform provided by LOXAM was used for the cleaning work.

With the aid of a high-pressure jet and a rotating brush, the aeroplane has been carefully cleaned.

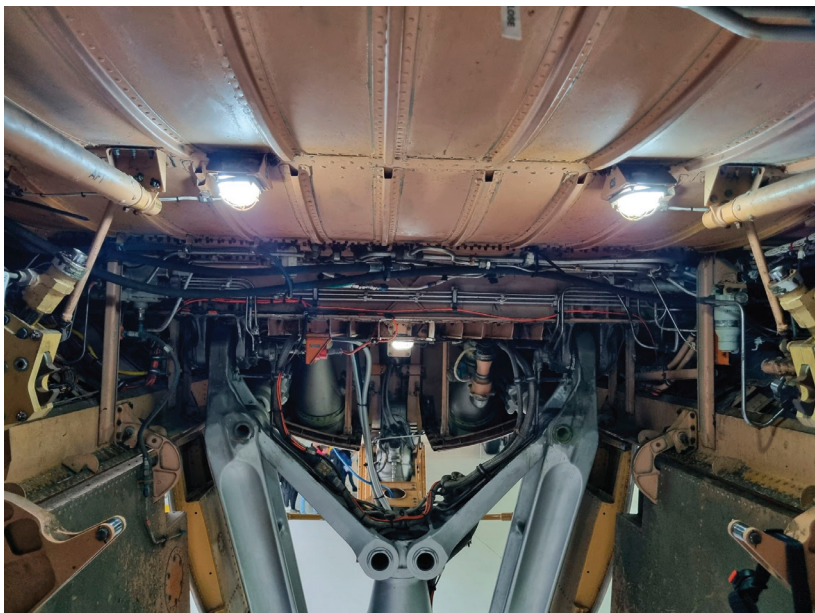
Nose landing gear bay

A view inside the bay, facing aft, showing the main doors and part of the hydraulic system.

Nose hydraulic system

We inspect and test the nose hydraulic system at least every 6 months as a matter of course, but in this case James and Graham were working to solve some small issues and leaks. We hope to quieten down the operation of AXDN's nose; as we now have four working noses in the UK and G-AXDN was the first one to be restored, we can now spend time fine-tuning and improv-

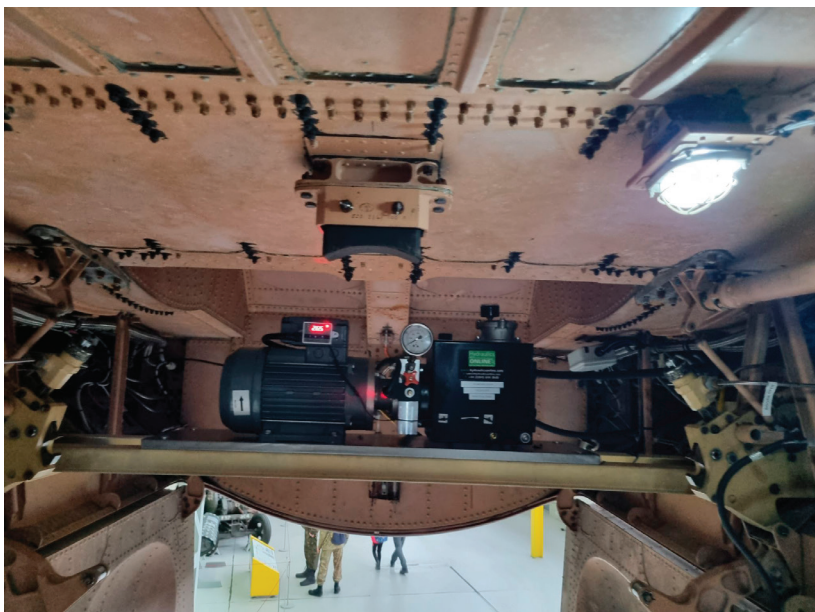
Hydraulic pump for the nose

Interior of the NLG bay, facing forward; the pump has now been located inside the NLG bay so that it can operate the nose and visor without any visible trailing cables.

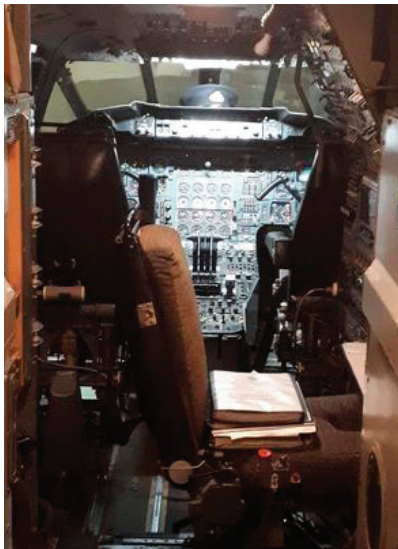
Visitor's view

The cockpit lighting before the latest round of adjustments. Heritage Concorde thanks Mark Wiles for alerting us to this issue and supplying this photograph.

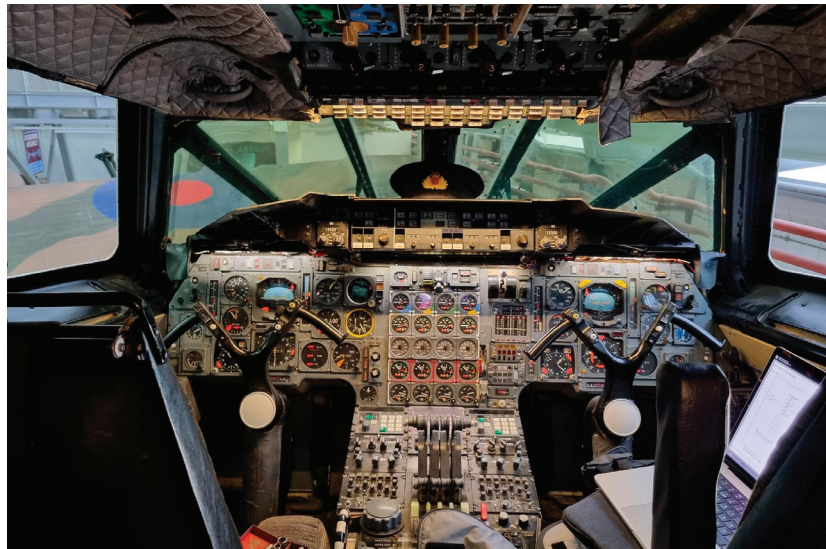
Improved cockpit lighting

New lighting has made the cockpit area and instrumentation brighter and more attractive for visitors.

We continued with fitting the lighting in the cockpit for general guests. We get to see the cockpit lit up each time we visit, but we rarely look to see what general guests see; when a photo of the cockpit was posted by one of our forum members (Mark Wiles), we realised that significant improvements could be made to the lighting inside the cockpit. John Dunlevy has taken the bull by the horns and is installing lighting to improve the view from the tunnel for general guests. As you can see, the improvement is significant. This project should be complete by our next visit.

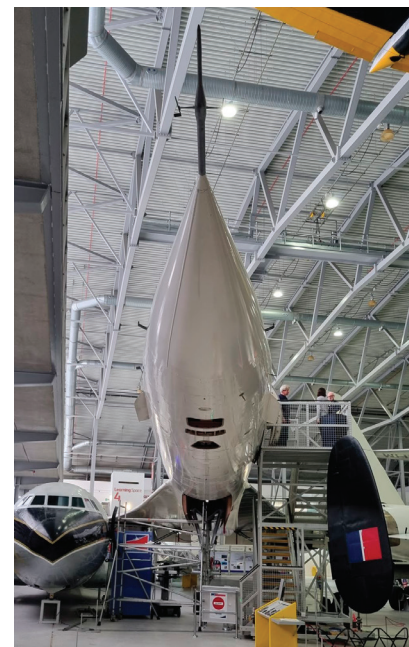
Latest view of G-AXDN

Ready for display and operation, with no visible cabling.
